PUBLICATION INDEX FOR SGS 1-34

K & L SOARING, LLC 5996 STATE ROUTE 224 CAYUTA, NY 14824

BULLETIN NO. SA-001.6* DATE: Dec 29, 2009

SUBJECT: ONE-TIME INSPECTION OF TOW RELEASE ASSEMBLY; DAILY INSPECTION OF TOW RELEASE ASSEMBLY: PILOT'S PREFLIGHT INSPECTION OF TOW RELEASE ASSEMBLY; 100 HOUR/ANNUAL INSPECTION OF TOW RELEASE ASSEMBLY.

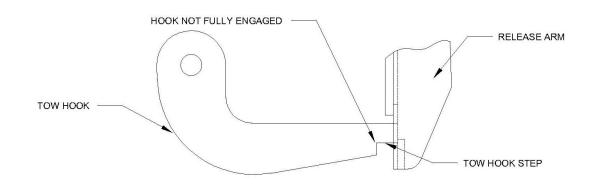
FIGURE 1 – ENGAGEMENT OF TOW HOOK INTO RELEASE ARM

VIEW A – PROPER ENGAGEMENT

VIEW B - IMPROPER ENGAGEMENT

NOTE: IF TOW HOOK IS ABLE TO SLIDE THROUGH RELEASE ARM, BEYOND THE TOW HOOK STEP, THE RELEASE ARM MUST EITHER BE REWORKED IN ACCORDANCE WITH FIGURE 3, OR REPLACED TOW HOOK TOW HOOK STEP

VIEW C – IMPROPER ENGAGEMENT

g. If tow hook is able to travel too far inboard as shown in Figure 1, View C, disengage tow hook from release arm and measure the length of the release arm slot

- h. If dimension is less than 0.66 inch, rework release arm by welding on 1B-217-19 slug at location shown in Figure 3. (Release arm may be replaced as an alternate to welding on slug)
- i. If length of release arm slot is greater than 0.66 inch, replace release arm.
- j. Perform a thorough inspection of the tow hook installation in accordance with the 100 hour inspection requirements listed in Table 2 of this bulletin.
- k. Repair of replace unserviceable component(s), as required
- I. Record compliance with Part I of this Service Bulletin in Aircraft Log Book.

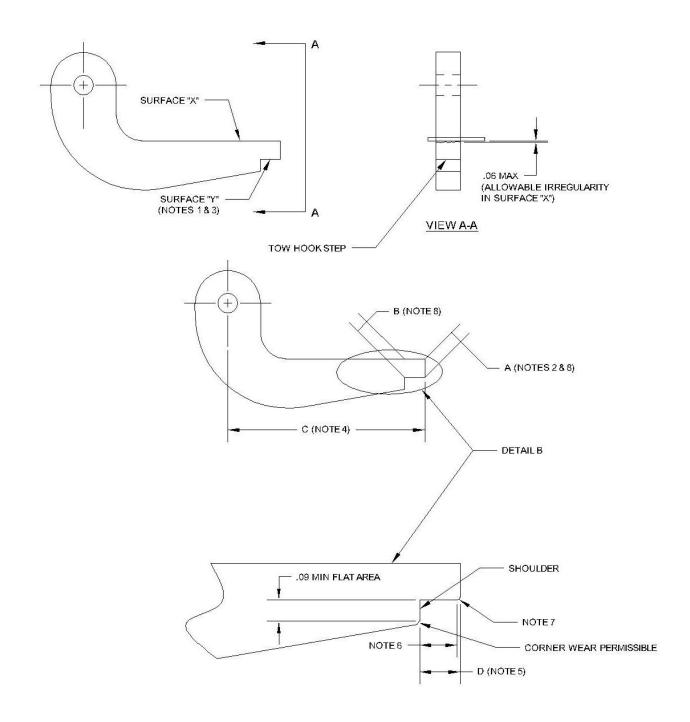
FIGURE 2 – TOW HOOK INSPECTION AND REWORK (SHEET 1 OF 2)

- IF WEAR OCCURS ON SURFACE "Y" IT MUST BE POLISHED FLAT WITHIN TOLERANCES PROVIDED IN FIGURE 2 (SHEET 1). IF THE HOOK CANNOT MEET THESE REQUIRED DIMENSIONS IT MUST BE REPLACED. UNDER NO CONDITIONS SHOULD SURFACE "X" BE POLISHED OR MACHINED TO CHANGE ITS ANGLE.

- 2. DIMENSION "A" ON STD 10232-001 HOOK SHALL BE .21 INCHES MIN. & .28 INCHES MAX. DIMENSION "A" ON STD 1A218-1A, STD 1B221-3, & R-200-9A HOOKS SHALL BE .25 INCHES MIN. & .31 INCHES MAX.

- 3. SURFACE "Y" MUST REMAIN FLAT, SMOOTH, AND WITHIN TOLERANCES SHOWN ON SHEET 1. (SEE ILLUSTRATION).
- 4. DIMENSION "C" ON STD 10232-001 HOOK SHALL BE 2.06 \pm .03 INCHES. DIMENSION "C" ON STD 1A218-1A, STD 1B221-3, & R-200-9A SHALL BE 3.00 \pm .03 INCHES.

- 5. DIMENSION "D" ON STD 10232-001 HOOK SHALL BE $.25 \pm .03$ INCHES. DIMENSION "D" ON STD 1A218-1A, STD 1B221-3, & R-200-9A SHALL BE $.31 \pm .03$ INCHES.

- 6. HOOK MUST REMAIN FLAT IN THIS AREA FOR A MIN. OF .21 INCHES FROM SHOULDER OF HOOK.
- 7. WEAR OUTSIDE OF THE .21 MIN. FLAT AREA IS PERMISSABLE.
- 8. DIMENSION "B" MUST BE EQUAL TO DIMENSION "A", OR LESS THAN DIMENSION "A" BY NO MORE THAN .015 INCHES AND CANNOT BE GREATER THAN DIMENSION "A".

- d. If tow hook dimensions are not within limits specified in Figure 2, either rework the tow hook to obtain dimensions (as specified in Figure 2) or replace it with a new or serviceable, used tow hook
- e. Engage tow hook into release arm. Ensure that the tow hook properly engages as shown in Figure 1, View A.
- f. If tow hook is unable to completely engage (shown by Figure 1, View B) shorten the rubber bumper stop between the release knob and the instrument panel to allow the release assembly to close further.

- 9. ALL SURFACES EXCEPT SURFACE "X" MAY BE FILLED TO OBTAIN REQUIRED DIMENSIONS.

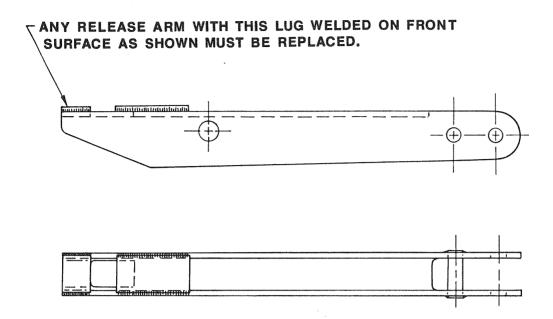
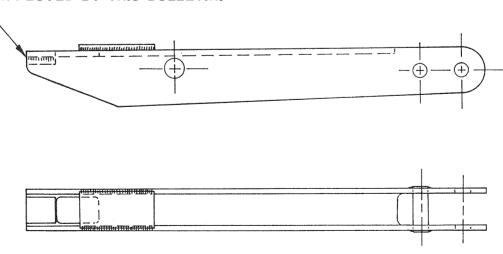
FIGURE 1. RELEASE ARM

- The suspect release arms (PN's 1D217-13, 1D222-15, 1D222-17, and 34017-15) may be identified by the presence of a lug welded on the front of the arm, below the tow hook slot. (Refer to Figure 1.)

RELEASE ARMS WITH THIS LUG WELDED ON THE INSIDE AS SHOWN ARE NOT AFFECTED BY THIS BULLETIN.

- Replace suspect release arms as follows:
 - (1) Replace 1D217-13 arm with 1D217-9 arm,
 - (2) Replace 1D222-15 arm with 1D222-11 arm,
 - (3) Replace 1D222-17 arm with 1D222-13 arm,

- (4) Replace 340170-15 arm with 34017D-11 arm.
- b. Remove and replace all suspect release arms (arms which incorporate lug welded to front, below tow hook slot) with acceptable replacement arm as specified in preceding NOTE.

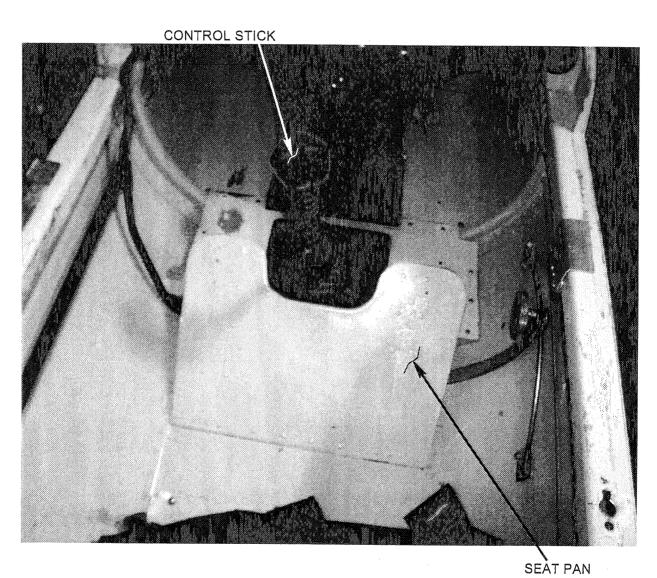
Figure SA-012-1. Seat Pan in Normal Position (Bottom Seat Cushion Removed)

PREFACE: • On the affected models, the forward seat pan may be inadvertently installed with the pan hinge oriented incorrectly. This condition moves the pan forward far enough to significantly limit the control stick/up elevator travel; resulting in restricted nose-up control. The purpose of this Bulletin is to ensure that the seat pan is installed correctly (PART I), and to prevent incorrect installation during future maintenance (PART II).

- a. Remove the bottom seat cushion to gain access to the seat pan (Fig. SA-012-1).
- b. Raise the seat pan to a partially open position and observe that the lower hinge half is positioned forward of the hinge pin as shown on Fig. SA-012-2, Detail A. This is the correct orientation. (If the lower hinge half is positioned aft as shown on Detail B, the seat pan is in the wrong location and this condition must be corrected before further flight.)
- c. With the seat pan raised, check the control stick/elevator range of motion; perform the same check with the seat pan in normal (down) position. Verify that range of motion is not affected by seat pan position.
