PUBLICATION INDEX

SCHWEIZER SAILPLANES

K & L SOARING, LLC
5996 STATE ROUTE 224
CAYUTA, NY 14824

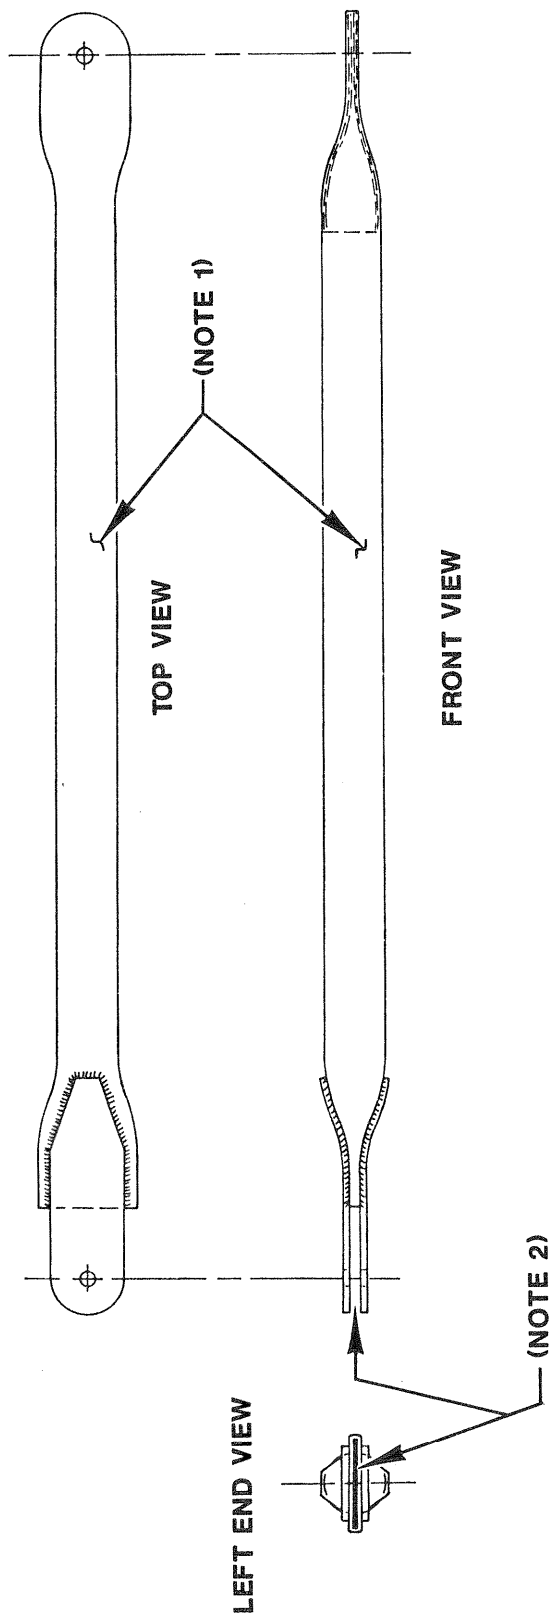
FIGURE 1. ELEVATOR PUSHROD (P/N 26B-12 -1A)

PREFACE: Field reports have indicated a possibility of corrosion of the subject 26B-123-1A push rod assembly. This corrosion, if left uncorrected, could lead to failure of the push rod, resulting in a loss of control of the elevator. This Service Bulletin provides instructions for a repetitive visual inspection of the subject push rod assembly. Any corrosion (no matter how slight) found during the inspection is cause for removal of the push rod assembly (PN 26B-123-1A) from service. 26B-123-1A push rods which are found to be completely free of corrosion may be returned to service after a coat of hot linseed oil is applied to the push rod interior surface, as set forth here in. It should be noted that the 26147B push rod is made from an improved design and is not subject to the inspection specified in the below procedure.

- NOTES: 1. INSPECT EXTERIOR OF PUSHROD FOR CORROSION.
NO CORROSION IS ALLOWED.
2. INSPECT INTERIOR SURFACE OF PUSHROD FOR CORROSION BY SHINING
HIGH INTENSITY LIGHT THROUGH OPEN END OF TUBE.
NO INTERIOR CORROSION IS ALLOWED.

- e. If any interior or exterior corrosion is found, replace push rod with a serviceable 26147B-1 push rod. If there is any question whether interior or exterior corrosion exists, replace push rod or consult the factory.

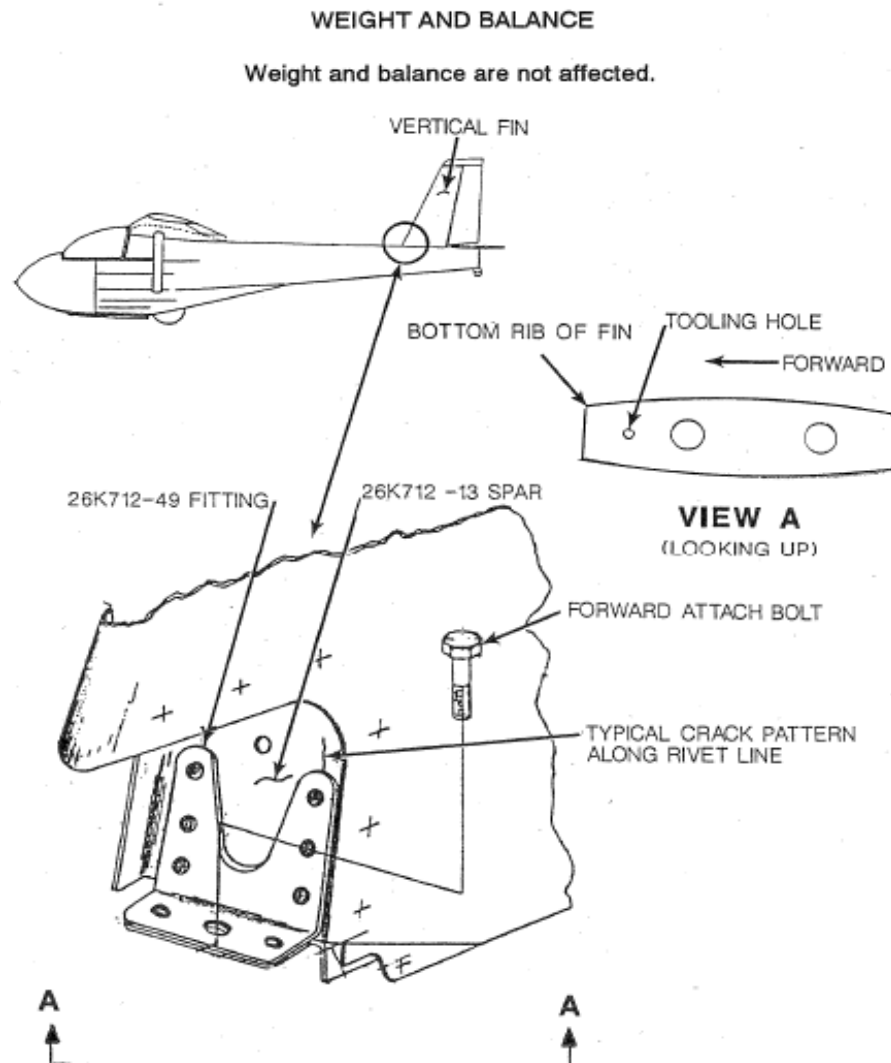
Figure SA-008-1 Vertical Fin Forward Attach Point

- D. If cracking is suspected, but not confirmed, or if the forward fin attach bolt is loose, perform the following:
1. Remove the vertical fin from the aircraft (2-33 & 2-33A Manual)
 2. Enlarge the forward tooling hole in bottom rib of vertical fin to one inch maximum (Figure SA-008-1, Detail A). Use the enlarged hole for visual access to inspect for cracking on the back side of the -13 spar. If cracking is found, perform step C above.
 3. Install vertical fin on aircraft (2-33 & 2-33A Manual)
FAA AD Note 76-13-11 was previously performed, remove plugs from above
- E. Ensure that forward fin attach bolt is tight; then install access cover on vertical fin.
- F. Record compliance with this Service Bulletin in the aircraft records.

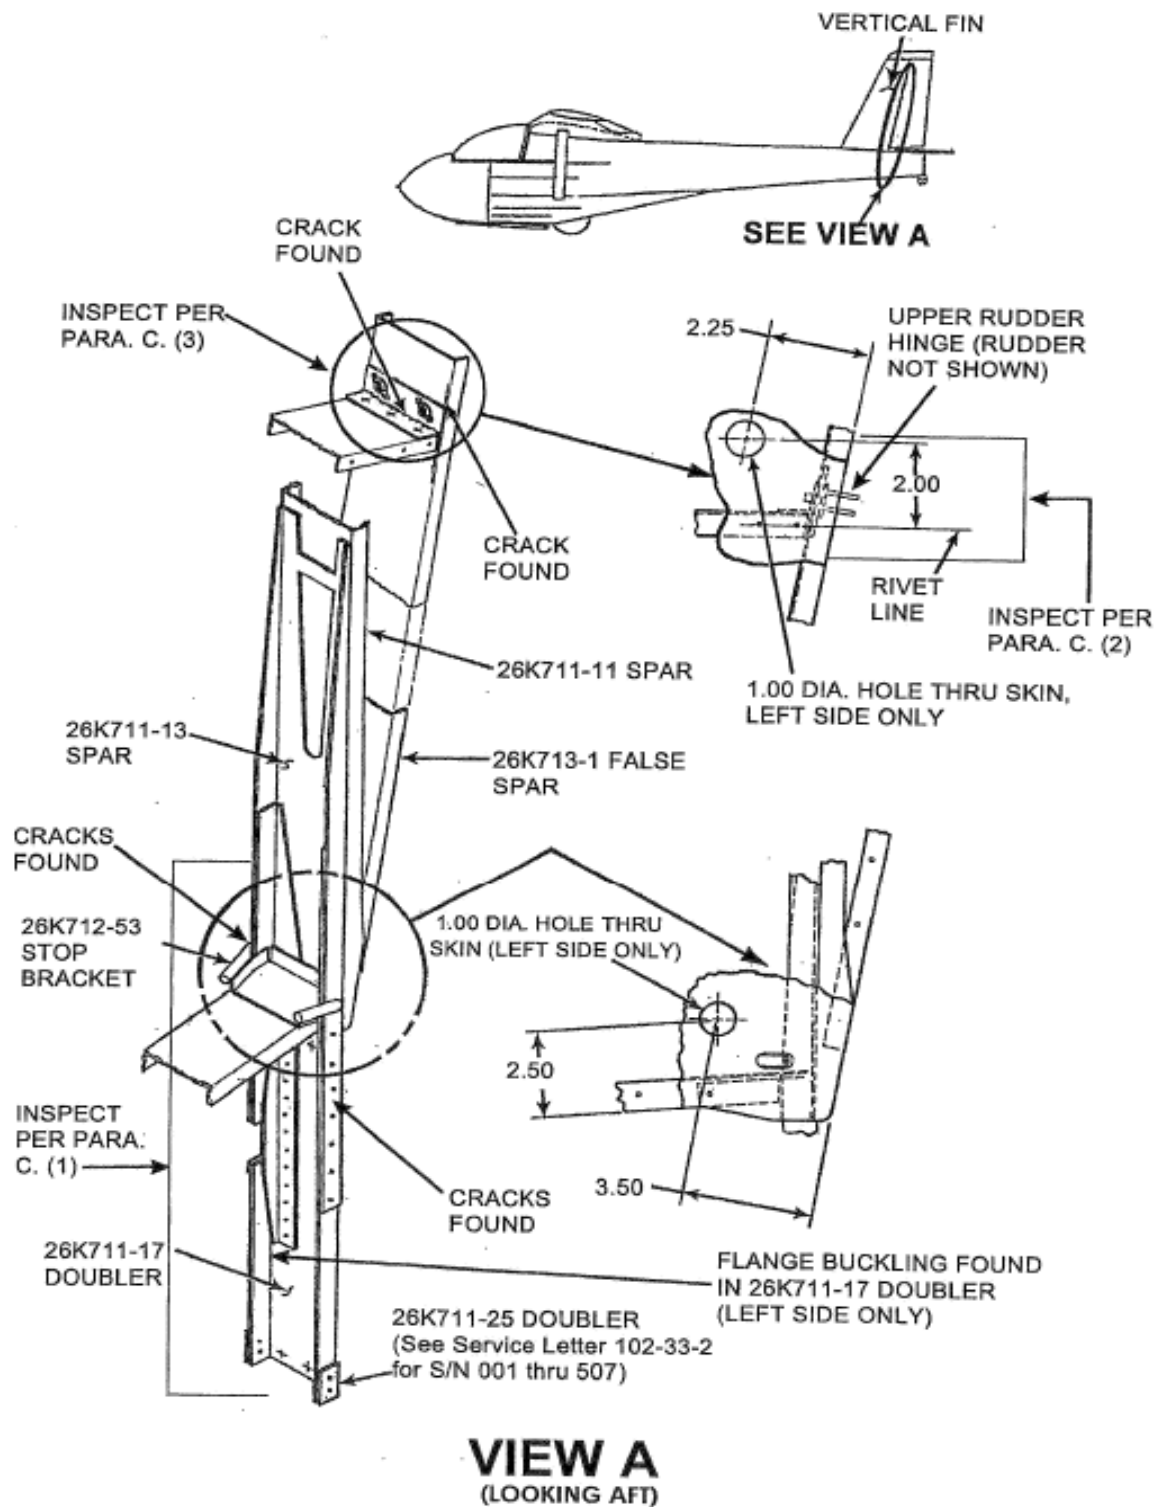
Figure SA-010-1. Vertical Fin Rear Spar Inspection

3. Through the upper hinge inspection hole, inspect the clip angle and false spar for cracking forward of the upper rudder hinge (Figure SA-0101-1)
- D. If damage is found, remove the aircraft from service and contact K&L Soaring for repair instructions. (607) 594-3329

- E. If no damage is found, install a snap plug BPF-1 in each of the 1.00 inch diameter holes in fin; reinstall fin/fuselage gap and hand hole covers.
- F. Record compliance with this Service Bulletin in the aircraft records.

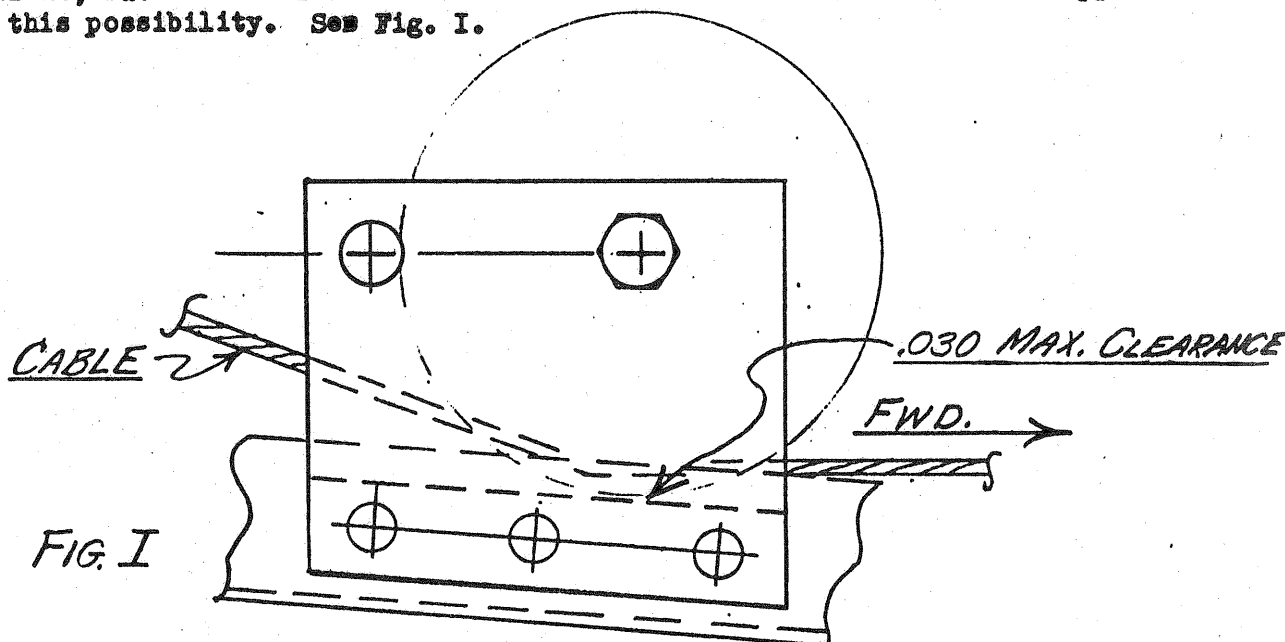
A case of spoiler control jamming has occurred on a 1-23G caused by excessive clearance between spacer block and spoiler control pulley just aft of main wing bulkhead fuselage, Sta. 76, near bottom of fuselage. This condition may exist in any of the above aircraft. The jamming has occurred only once and should not occur under normal conditions, but all aircraft should be checked and the correction below applied to eliminate this possibility. See Fig. I.

Check by using feelers inserted from aft end to determine gap between pulley and 23D117-2 block. If this exceeds .030, correction should be made as follows:

(1) Schweizer Aircraft Corp. can furnish an oversize blank 23D117-2 replacement which can be installed to bring the clearance between .010 to .030. Since this is difficult to do in the field due to the confined space, the alternate method No. 2 may be used.

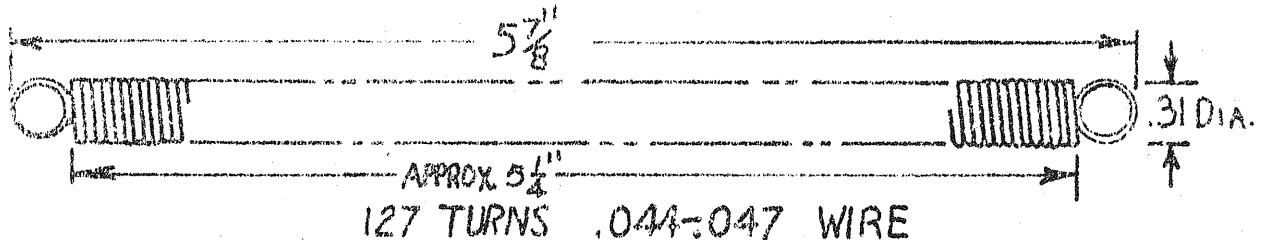
1. There are three alternate springs used in the 1-26 tow release mechanism. From field reports from owners, it appears there are cases of excessively high release operating loads. We have run tests and have determined that the best spring is our No. 1A113-1 shown below.

All 1-26's should be equipped with this spring. The installation should be checked by pulling on the release arm just below the hook with a small spring scale. This should require from 6-12 lbs. pressure to release. (See note on page 2).

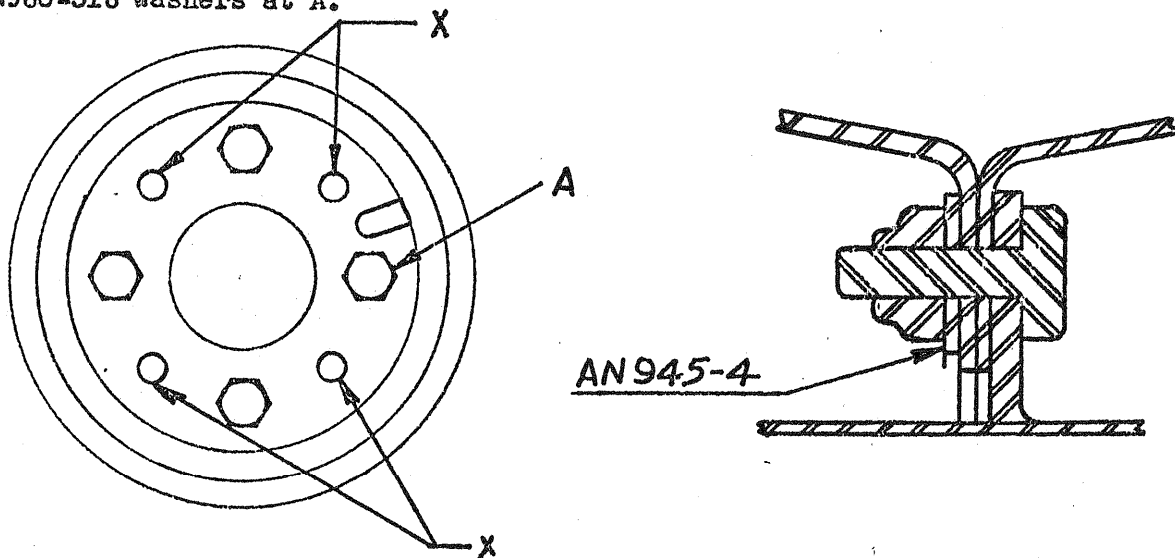
A few failures have occurred in the field to the 1-26 Wheel Assembly--
26B201. This failure has occurred in the stamped flange at the edge of the bolt
heads. To eliminate this condition, the following procedure should be used. This
is not a safety of flight item, but it will eliminate the possibility of a wheel
failure. The change is being incorporated in new production 1-26 sailplanes.

Procedure: Take the wheel assembly out of the ship and drill thru the four holes
at X that do not have bolts with a 5/16" drill, install an AN 5-6A bolt, AN945
washer, and AN365-524 nut. Then remove the original four bolts and reinstall with
AN945-4 washers. Note that all bolts will be installed with the washer between
the nut and the wheel flange. (See sketch below). The one bolt next to the valve
stem does not have room for the AN945 washer. On this bolt use one of the exist-
ing AN960-516 washers at A.

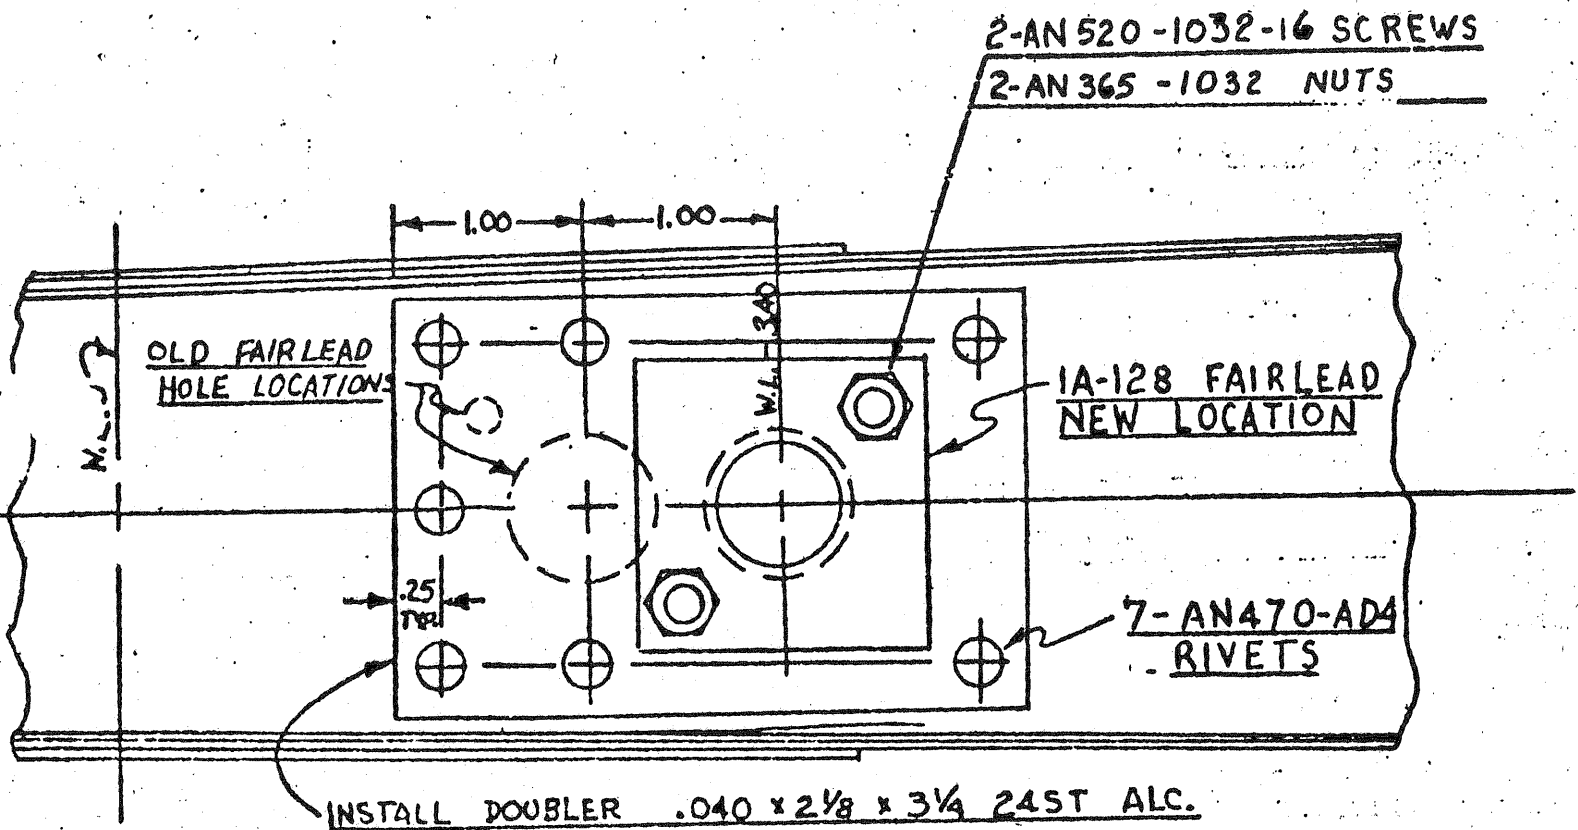
A condition has been discovered which could cause excessive wear on the 26B120-2A Elevator Control Cable at the 1A-128 Fairlead on the Fin Spar. This wear would be induced by the location of the 1A-128 Fairlead at W.L.--2.40. This condition exists on all ships to and including Ship No. 75.

The condition noted may be eliminated by relocation of the 1A-128 Fairlead to W.L. 3.40 according to the attached sketch. Material kits for this work are available upon request.

We recommend the accomplishment of this relocation at the earliest convenience and thorough inspection of the area and parts for indications of wear, each 25 hours until the relocation is made.

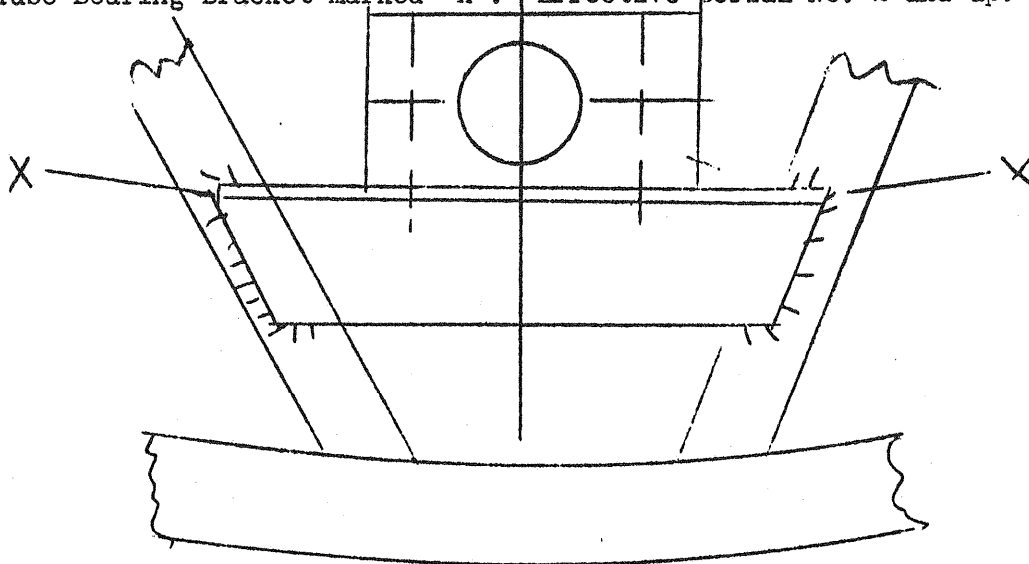
REF 26H136

We have a field report of a weld failure at the forward Control Torque Tube Bearing Bracket marked "X". Effective Serial No. 2 and up.

While we believe this to be an isolated case, we feel that this point should be checked before flight by all owners. It is readily accessible for inspection. If any cracks are found, please advise us.
