PUBLICATION INDEX

SGS 2-22

K & L SOARING, LLC
5996 STATE ROUTE 224
CAYUTA, NY 14824

SUBJECT: INSPECTION OF FUSELAGE FRAME STRUCTURE

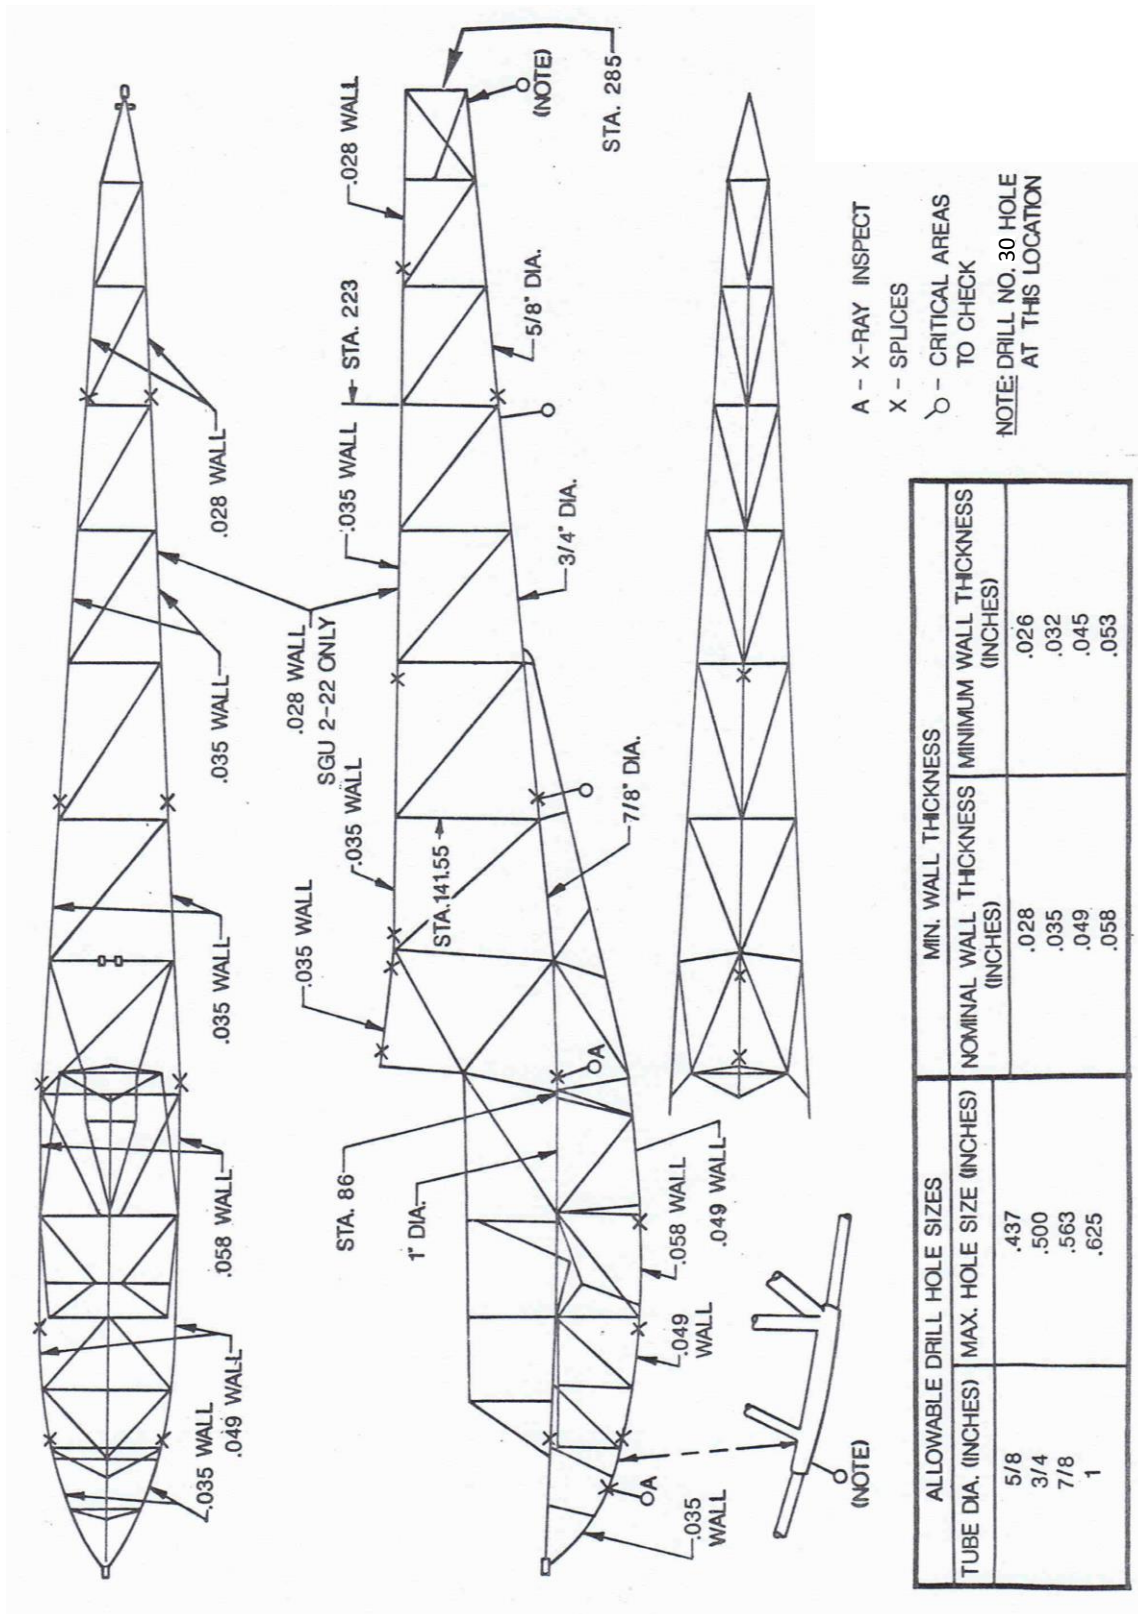
Figure 1 - Tube Dimension and Minimum Wall Thickness

As an alternate to x-raying tubes for internal corrosion in next step, holes may be drilled at splices (areas marked A on Figure 1) to visually inspect the ID of the tubes. The holes should be drilled about 45 degrees in the lower outboard quarter of the tube just ahead of the splices. In the tail wheel area, enlarge number 30 holes to 7/16 inch maximum. (Refer to Figure 1 for other allowable hole sizes.) If corrosion exists, measure the wall thickness as shown in Figure 2. Tubes which have a wall thickness which is less than the limit specified in Figure 1, must be replaced.

- C. If water drains from holes, x-ray inspect splices of longeron tubes that are marked A on Figure 1.
- D. If any corrosion is evident, proceed as follows:
- a. Drill holes at suspect locations. (Refer to Figure 1 for maximum allowable hole size)
 - b. Measure the wall thickness as shown in Figure 2.
 - c. If wall thickness is less than the required limit (specified in Figure 1), repair or replace the tube in accordance with AC 43.13

- E. Visually inspect longeron tubes for external corrosion from inside the aircraft.
- F. If external corrosion is evident, drill holes and measure wall thickness in accordance with steps D (a) and D (b) above. If wall thickness is less than required limit (specified on Figure 1), repair or replace tubes in accordance with AC 43.13.
- G. With a dull ice pick, perform a prod test at one inch intervals along entire length of the lower surface of the longerons from station 141.55 aft to station 285.00. If ice pick penetrates tube, drill holes and measure wall thickness as specified by steps D (a) and D (b) above. If wall thickness is less than the required limit (specified on Figure 1), repair or replace tubes in accordance with AC 43.13.

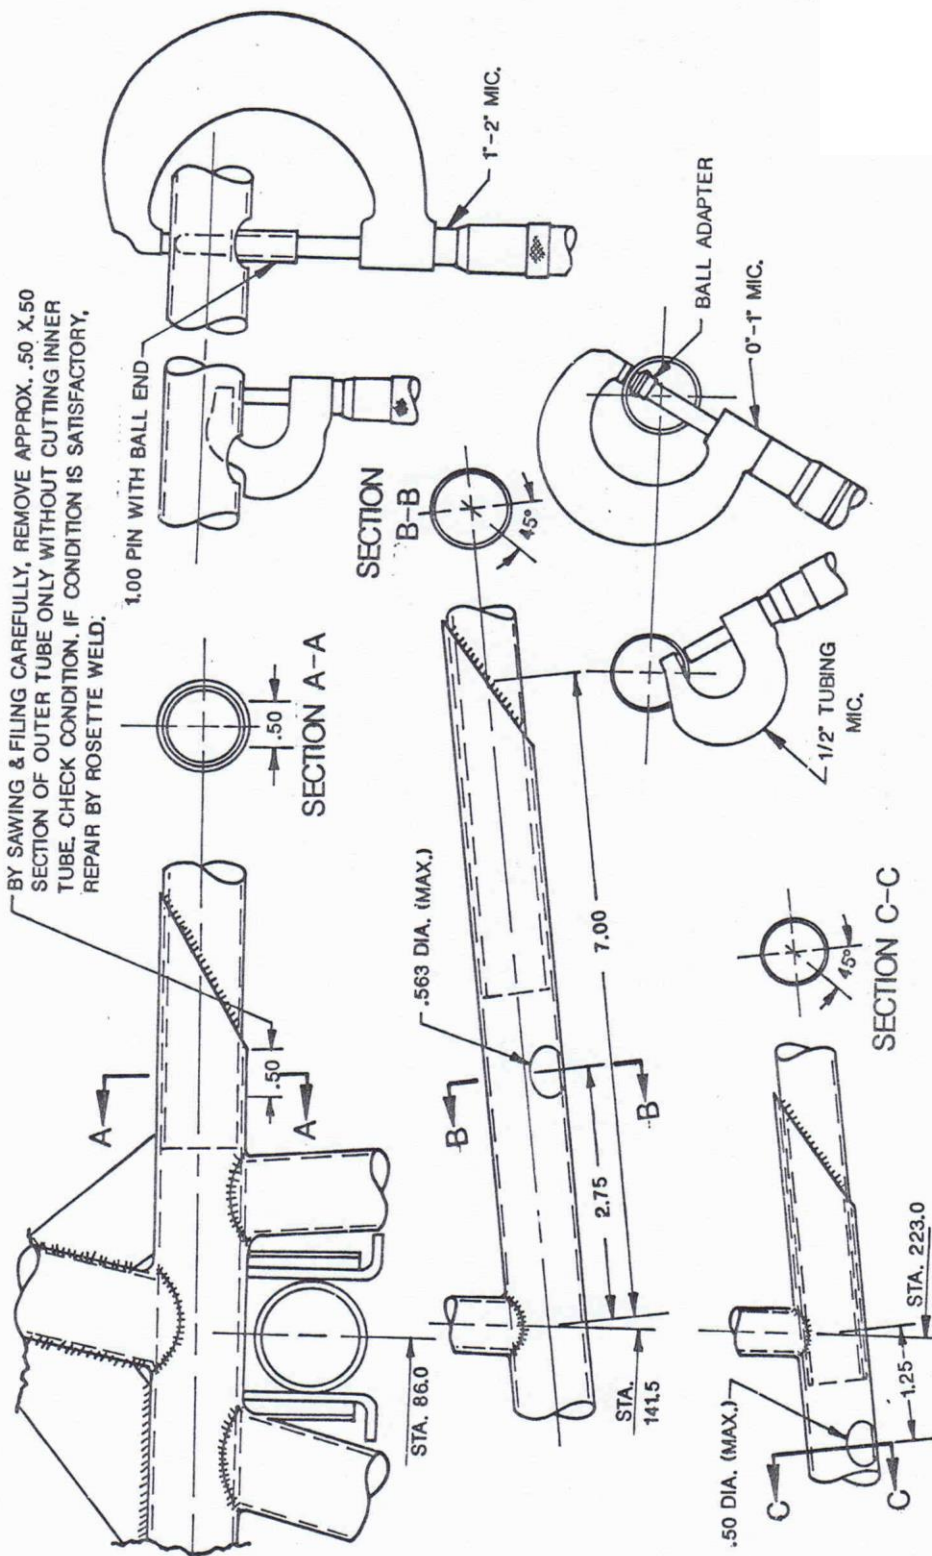
Figure 2 - Measuring of Tube Wall Thickness

NOTE: TO MEASURE WALL THICKNESS, USE A 1/2 INCH BALL MICROMETER AND A BALL END PIN. BE SURE TO FIRST MEASURE THE LENGTH OF THE PIN AND THEN SUBTRACT THAT LENGTH FROM THE MEASUREMENT OF THE PIN AND WALL THICKNESS.

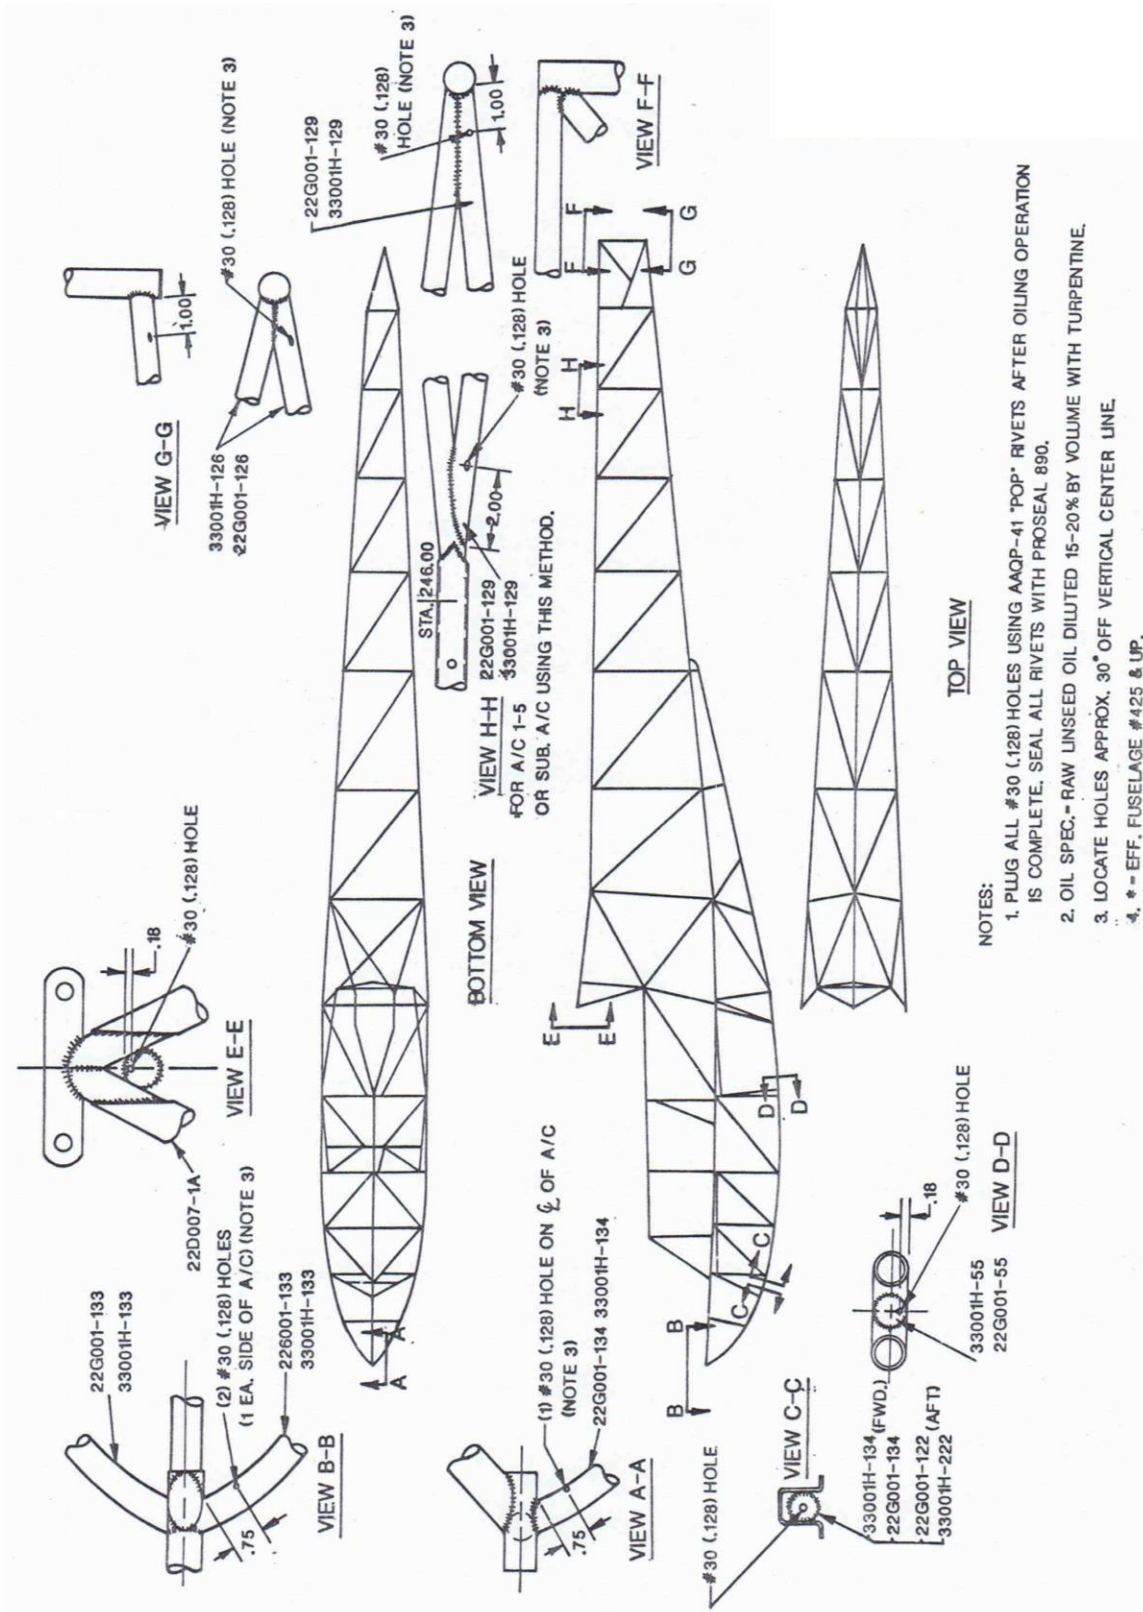
Figure 3 - Anti-Corrosion Treatment

- NOTES:
1. PLUG ALL #30 (.128) HOLES USING AAQP-41 "POP" RIVETS AFTER OILING OPERATION IS COMPLETE. SEAL ALL RIVETS WITH PROSEAL 890.
 2. OIL SPEC. = RAW LINSEED OIL DILUTED 15-20% BY VOLUME WITH TURPENTINE.
 3. LOCATE HOLES APPROX. 30° OFF VERTICAL CENTER LINE
 4. * = EFF. FUSELAGE #425 & UP.

- b. Use hand or power pump to fill longeron tubes with oil through holes drill for inspection. (Drill additional holes as required to fill tubes. Refer to Figure 3 for recommended hole locations and diameters)
- c. Allow oil to drain from tubes.

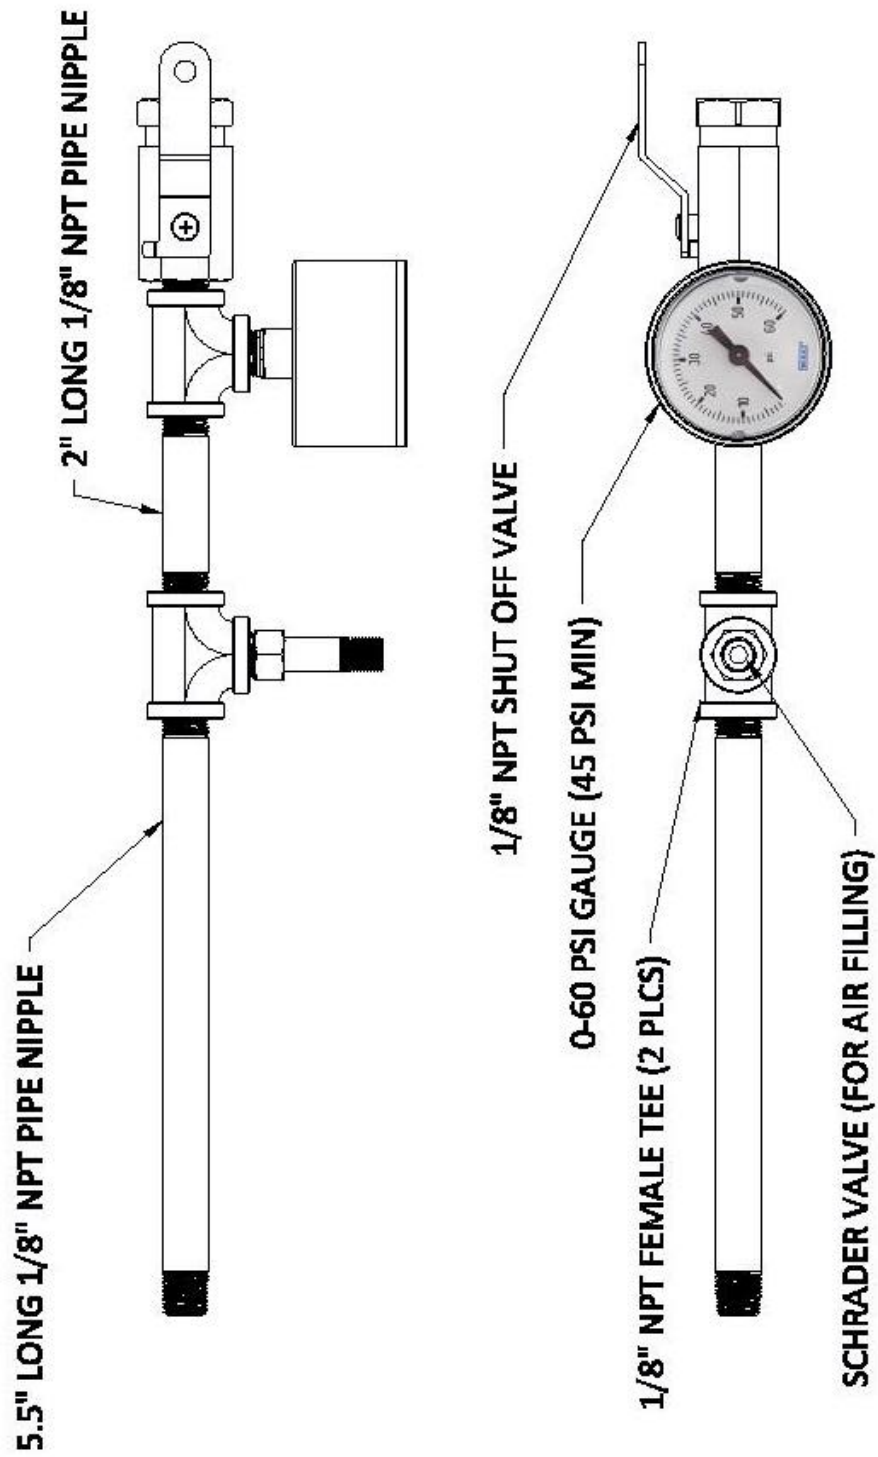
Figure 4 – Pressure Check Gauge

1. Reinstall all plugs except behind rear seat in upper longeron
 2. Install a pressure check gauge similar to what is shown in Figure 4 in upper longeron behind rear seat
 3. Using compressed air fill fuselage up to 30 psi. Wait 1 hour and then refill fuselage to 30 psi
 4. Wait 6 hours. If fuselage pressure is below 15 psi the fuselage fails pressure check and K&L Soaring must be contacted before returning aircraft to service.
- C. Reinstall threaded plugs from oiling kit
 - D. Record compliance with this Service Bulletin in the Aircraft Log Book

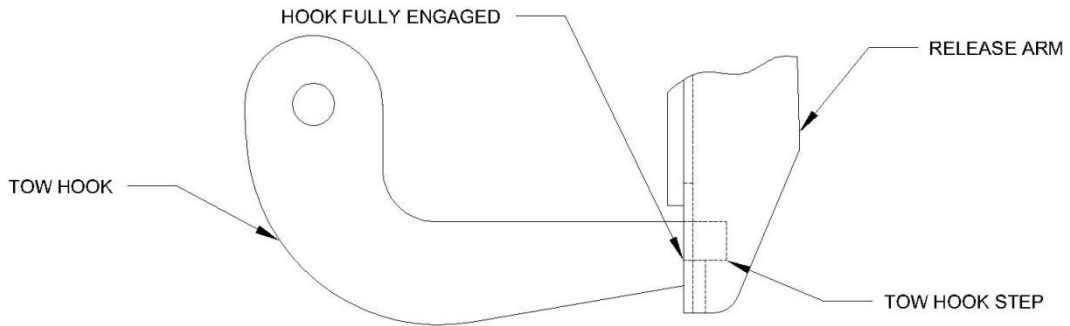
VIEW A – PROPER ENGAGEMENT

- Proper engagement of the tow hook into the release arm is shown in Figure 1, View A, and Figure 4. Excessive wear of the tow hook step could result in improper engagement. Figure 2 of this bulletin provides inspection data and wear limits for the tow hook. Tow hooks which do not meet the specified limits must either be reworked to obtain dimensions (as specified in Figure 2) or replaced.
 - If tow hooks is able to slide into the release arm, beyond the tow hook step, as shown by Figure 1, View C, the release arm must either be reworked with a slug as specified in Figure 3, or replaced.
- c. Inspect tow hook for wear in accordance with Figure 2 of this bulletin.

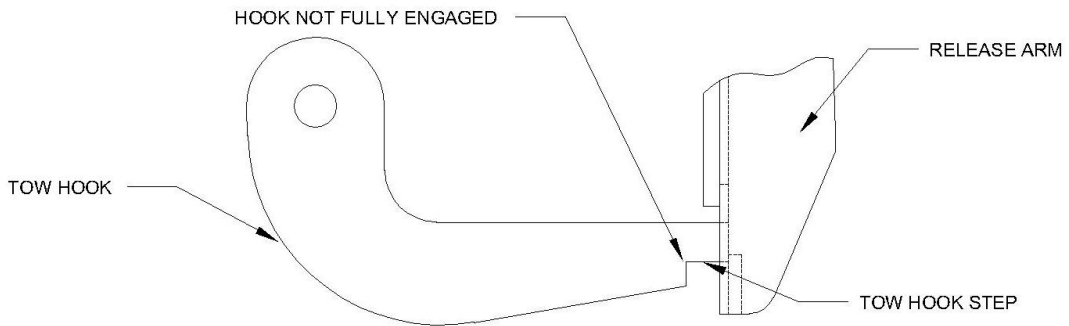
VIEW B – IMPROPER ENGAGEMENT

IF TOW HOOK IS ABLE TO SLIDE THROUGH RELEASE ARM, BEYOND THE TOW HOOK STEP, THE RELEASE ARM MUST EITHER BE REWORKED IN ACCORDANCE WITH FIGURE 3, OR REPLACED

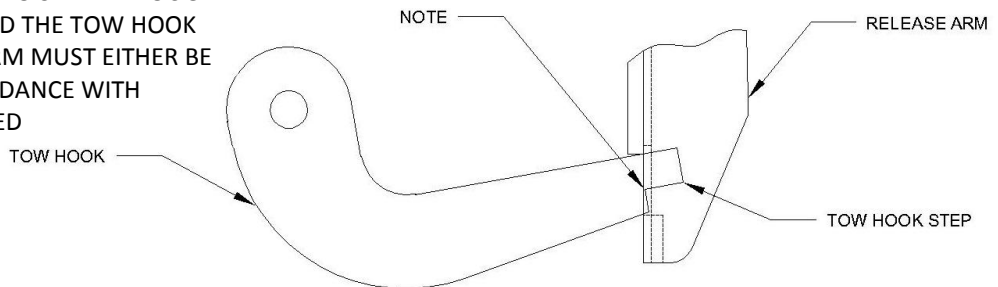
VIEW C – IMPROPER ENGAGEMENT

- g. If tow hook is able to travel too far inboard as shown in Figure 1, View C, disengage tow hook from release arm and measure the length of the release arm slot
- h. If dimension is less than 0.66 inch, rework release arm by welding on 1B-217-19 slug at location shown in Figure 3. (Release arm may be replaced as an alternate to welding on slug)
- i. If length of release arm slot is greater than 0.66 inch, replace release arm.
- j. Perform a thorough inspection of the tow hook installation in accordance with the 100 hour inspection requirements listed in Table 2 of this bulletin.
- k. Repair or replace unserviceable component(s), as required
- l. Record compliance with Part I of this Service Bulletin in Aircraft Log Book.

- Figure 1 shows the proper attachment of the tow hook into the release arm. Note that the step of the tow hook should seat against the release arm. The tow hook step must fully engage the release arm to allow the release assembly to function properly. The tow hook must not be allowed to extend through the release arm beyond the step on the hook as shown in Figure 1, View C.

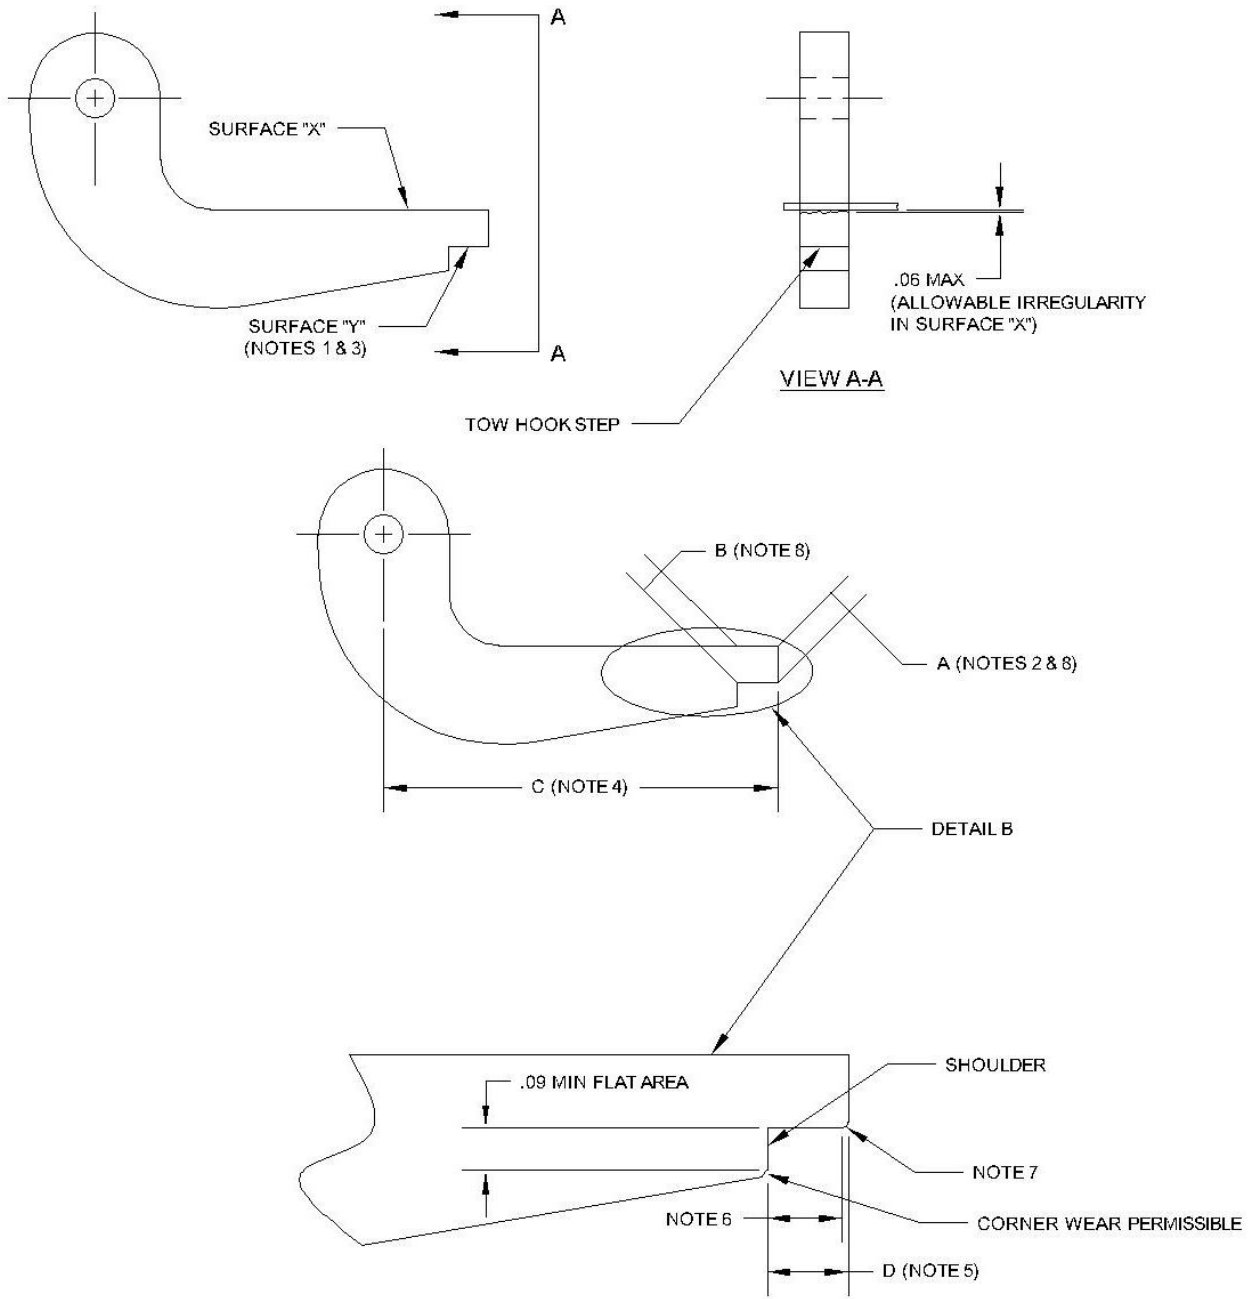
FIGURE 2 – TOW HOOK INSPECTION AND REWORK (SHEET 1 OF 2)

1. IF WEAR OCCURS ON SURFACE "Y" IT MUST BE POLISHED FLAT WITHIN TOLERANCES PROVIDED IN FIGURE 2 (SHEET 1). IF THE HOOK CANNOT MEET THESE REQUIRED DIMENSIONS IT MUST BE REPLACED. UNDER NO CONDITIONS SHOULD SURFACE "X" BE POLISHED OR MACHINED TO CHANGE ITS ANGLE.

2. DIMENSION "A" ON STD 10232-001 HOOK SHALL BE .21 INCHES MIN. & .28 INCHES MAX. DIMENSION "A" ON STD 1A218-1A, STD 1B221-3, & R-200-9A HOOKS SHALL BE .25 INCHES MIN. & .31 INCHES MAX.

6. HOOK MUST REMAIN FLAT IN THIS AREA FOR A MIN. OF .21 INCHES FROM SHOULDER OF HOOK.
7. WEAR OUTSIDE OF THE .21 MIN. FLAT AREA IS PERMISSABLE.
8. DIMENSION "B" MUST BE EQUAL TO DIMENSION "A", OR LESS THAN DIMENSION "A" BY NO MORE THAN .015 INCHES AND CANNOT BE GREATER THAN DIMENSION "A".

- d. If tow hook dimensions are not within limits specified in Figure 2, either rework the tow hook to obtain dimensions (as specified in Figure 2) or replace it with a new or serviceable, used tow hook
- e. Engage tow hook into release arm. Ensure that the tow hook properly engages as shown in Figure 1, View A.
- f. If tow hook is unable to completely engage (shown by Figure 1, View B) shorten the rubber bumper stop between the release knob and the instrument panel to allow the release assembly to close further.

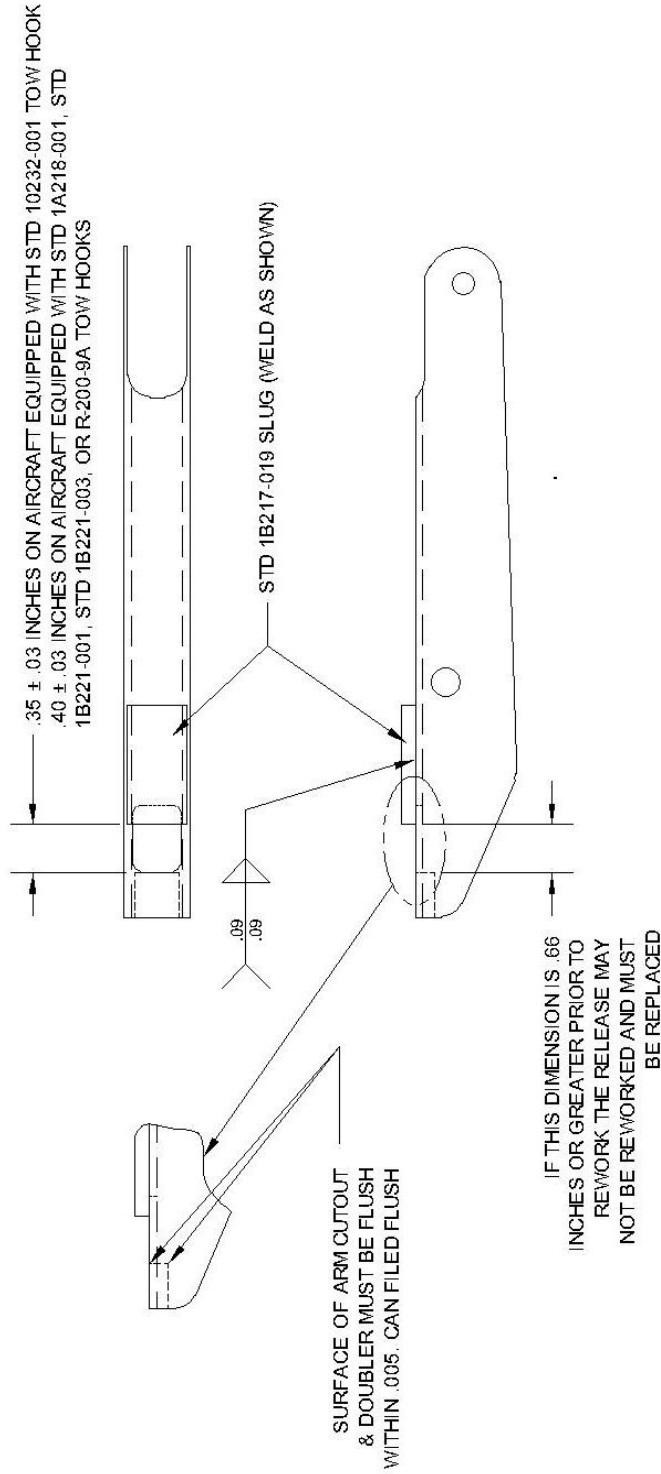
FIGURE 3 - REWORK OF RELEASE ARM

NOTE: ALL TOW RELEASE ARMS MUST BE REWORKED AS SHOWN ABOVE OR REPLACED WITH THE PROPER SUPERSEDING ARM AS SPECIFIED IN TABLE 1

**NOTE: STD 1B217-019 SLUG IS AVAILABLE FROM K & L SOARING, LLC
 0.125 X 0.5 X 1.0 4130N STEEL**

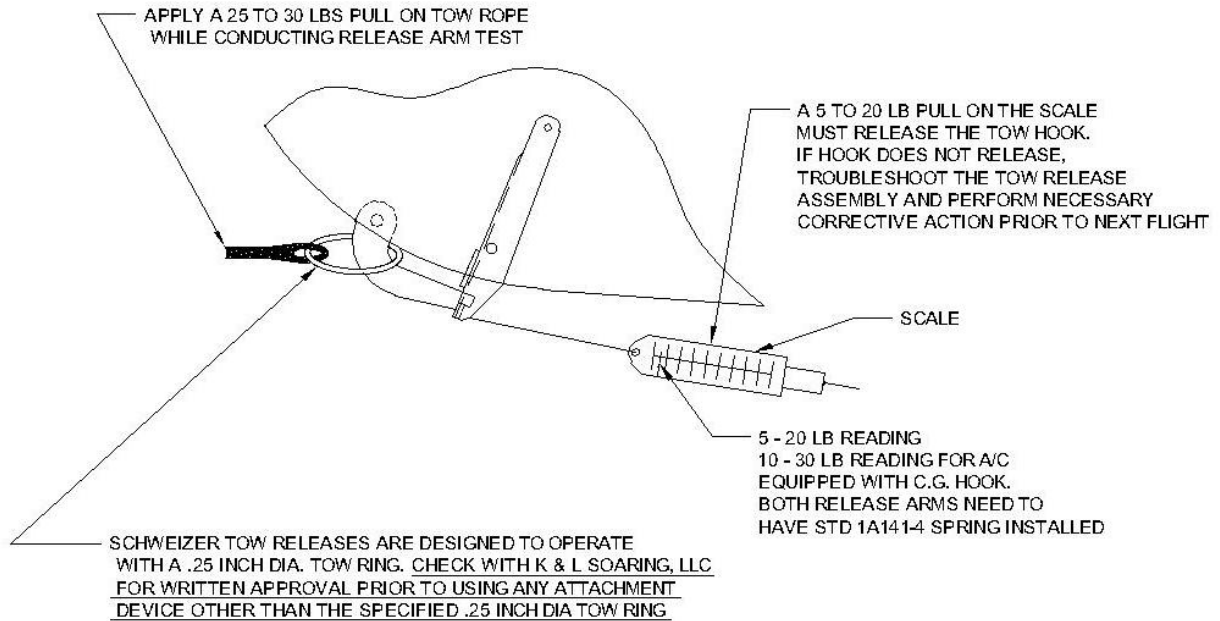
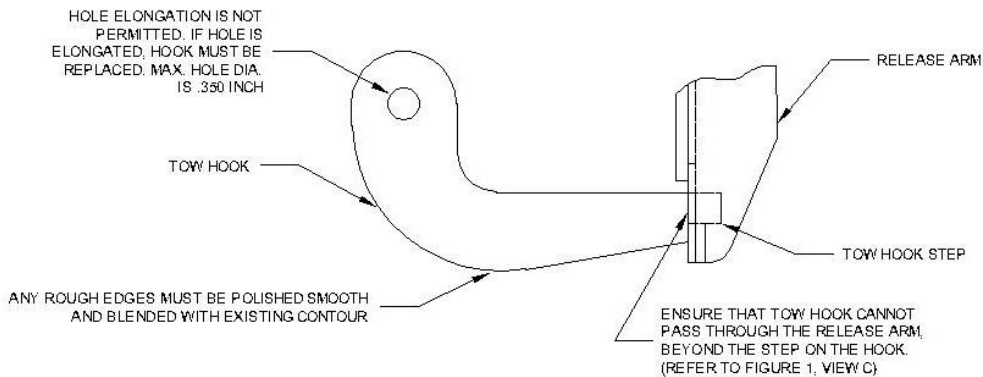
FIGURE 4 - PULL TEST OF TOW RELEASE ASSEMBLY

NOTE: IF RELEASE LOADS ARE TOO HIGH WITH C.G. SYSTEM IT IS PERMISSIBLE TO ADD A LINK TO SHORTEN STD 1A141-2 SPRING. LINK SHOULD BE MADE AS SHOWN BELOW. IF REQUIRED THEY SHOULD BE ADDED TO BOTH RELEASE ARMS TO BALANCE BOTH RELEASE SPRINGS
