PUBLICATION INDEX

SGS 1-26

K & L SOARING, LLC
5996 STATE ROUTE 224
CAYUTA, NY 14824

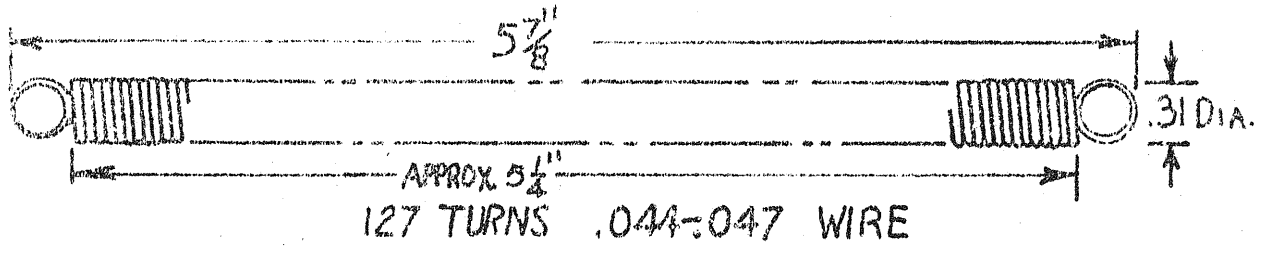
1. There are three alternate springs used in the 1-26 tow release mechanism. From field reports from owners, it appears there are cases of excessively high release operating loads. We have run tests and have determined that the best spring is our No. 1A113-1 shown below.

All 1-26's should be equipped with this spring. The installation should be checked by pulling on the release arm just below the hook with a small spring scale. This should require from 6-12 lbs. pressure to release. (See note on page 2).

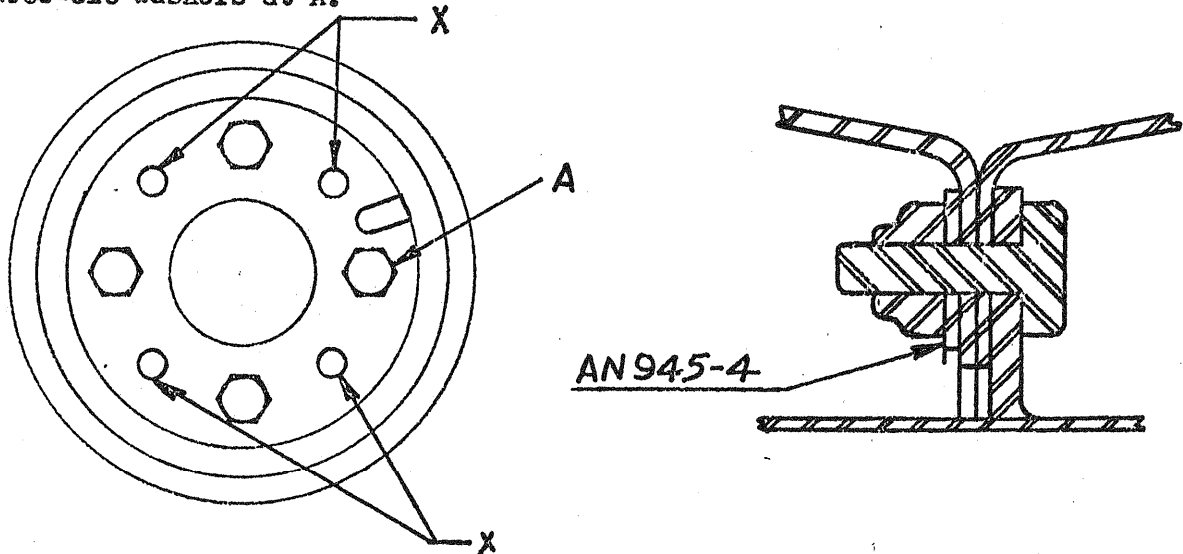
A few failures have occurred in the field to the 1-26 Wheel Assembly-- 26B201. This failure has occurred in the stamped flange at the edge of the bolt heads. To eliminate this condition, the following procedure should be used. This is not a safety of flight item, but it will eliminate the possibility of a wheel failure. The change is being incorporated in new production 1-26 sailplanes.

Procedure: Take the wheel assembly out of the ship and drill thru the four holes at X that do not have bolts with a 5/16" drill, install an AN 5-6A bolt, AN945 washer, and AN365-524 nut. Then remove the original four bolts and reinstall with AN945-4 washers. Note that all bolts will be installed with the washer between the nut and the wheel flange. (See sketch below). The one bolt next to the valve stem does not have room for the AN945 washer. On this bolt use one of the existing AN960-516 washers at A.

We are furnishing the following items to complete this modification--

4 AN5-6A, 7 AN945-4, 4 AN365-5.

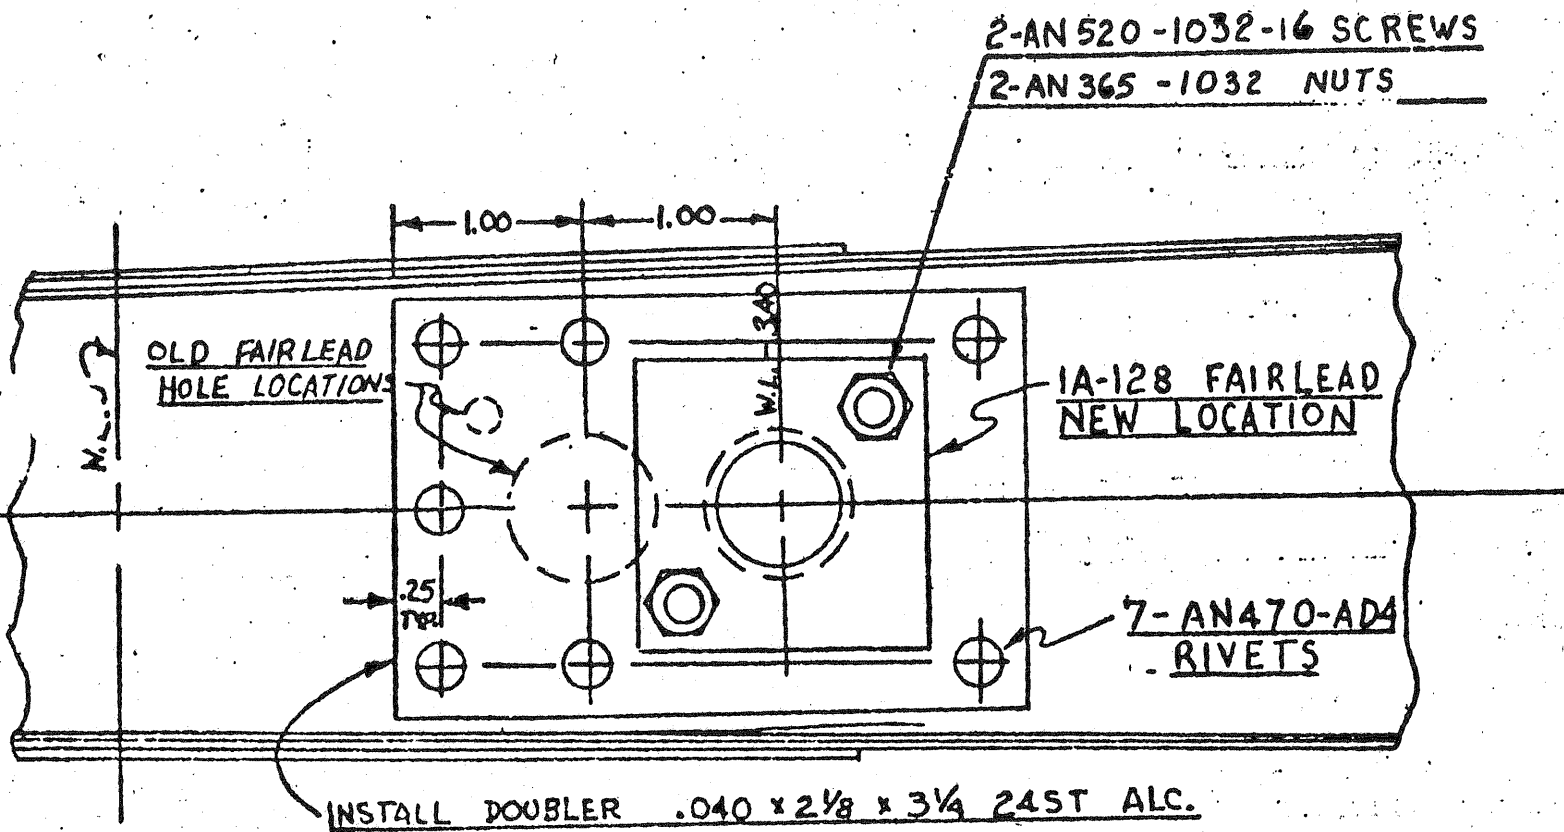
A condition has been discovered which could cause excessive wear on the 26B120-2A Elevator Control Cable at the 1A-128 Fairlead on the Fin Spar. This wear would be induced by the location of the 1A-128 Fairlead at W.L.--2.40. This condition exists on all ships to and including Ship No. 75.

The condition noted may be eliminated by relocation of the 1A-128 Fairlead to W.L. 3.40 according to the attached sketch. Material kits for this work are available upon request.

We recommend the accomplishment of this relocation at the earliest convenience and thorough inspection of the area and parts for indications of wear, each 25 hours until the relocation is made.

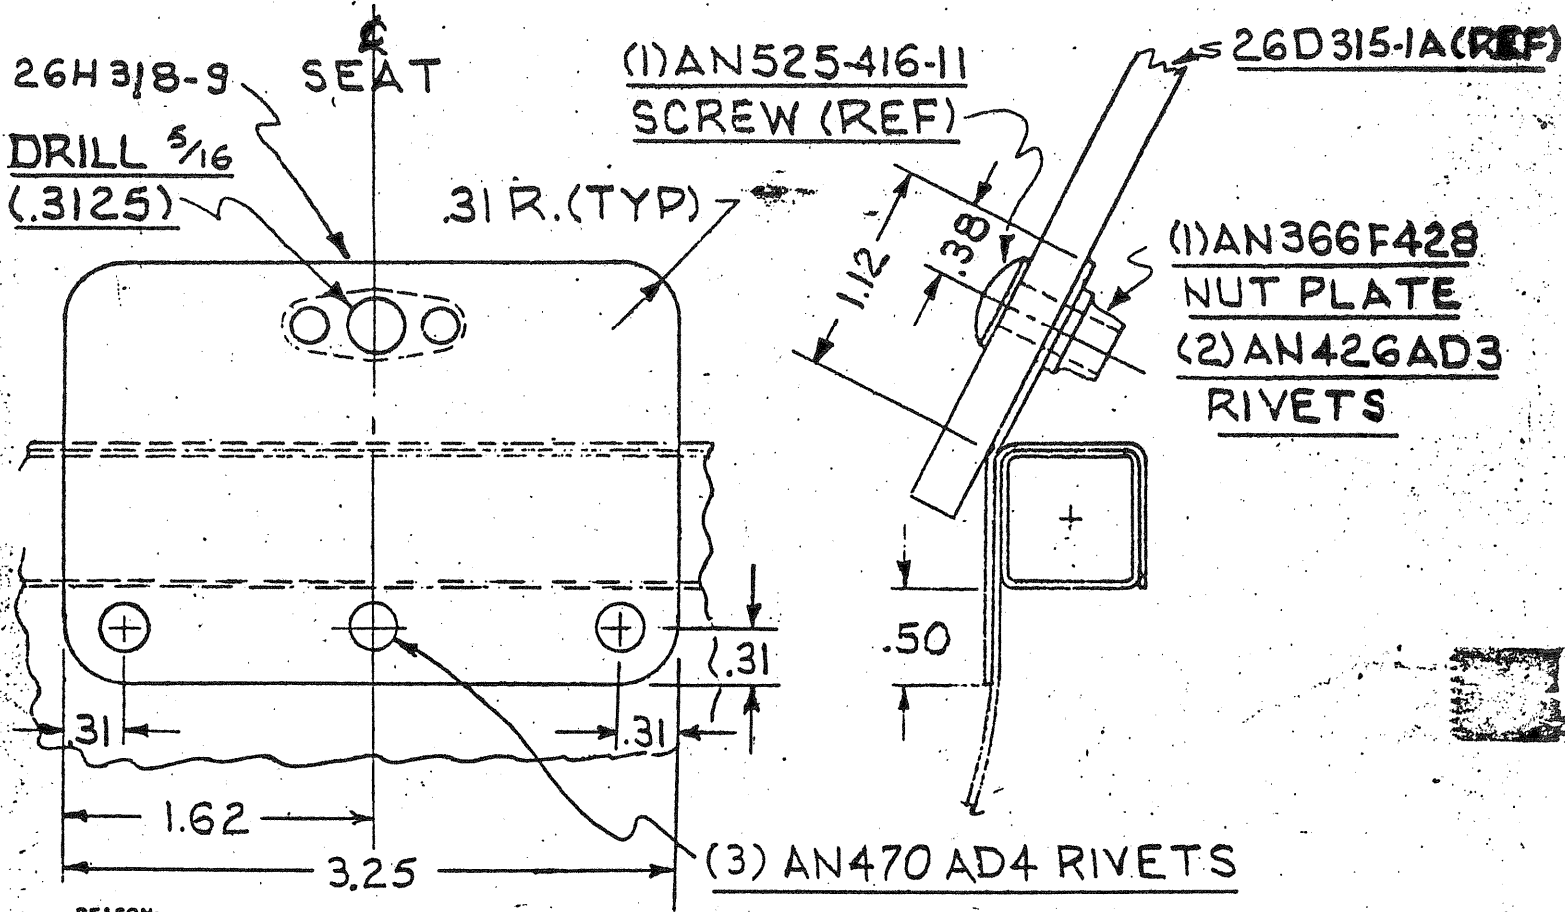
ENGINEERING CHANGE ORDER						CHG. LET.
TITLE:	SEAT BOTTOM					
CHG. INC.		EFFECTIVITY	OPT	PARTS AFFECTED		ECO. SERIAL
BY	W.E.F.	CARD POSTED	7.20.62	TOOLS AFFECTED		D.C.R. SERIAL
DATE	7.20.62	CHECKED	ES 2/15/62	STOCK DISPOSITION	—	DWG. NO.
						26-259
						—
						26H-318

There have been cases reported where the seat back, which is held at the bottom end by aluminum clips, has disengaged and moved back suddenly. This is disconcerting to the pilot and could cause loss of control at a critical flight condition.

CHANGE: ^{REV ES 9/10/62} I. ADD ATTACH PLATE TO SEAT AS SHN.
MAKE FROM .040 2024-T3 ALC

I. TO PROVIDE ADDITIONAL ATTACHMENT FOR SEAT BACK.

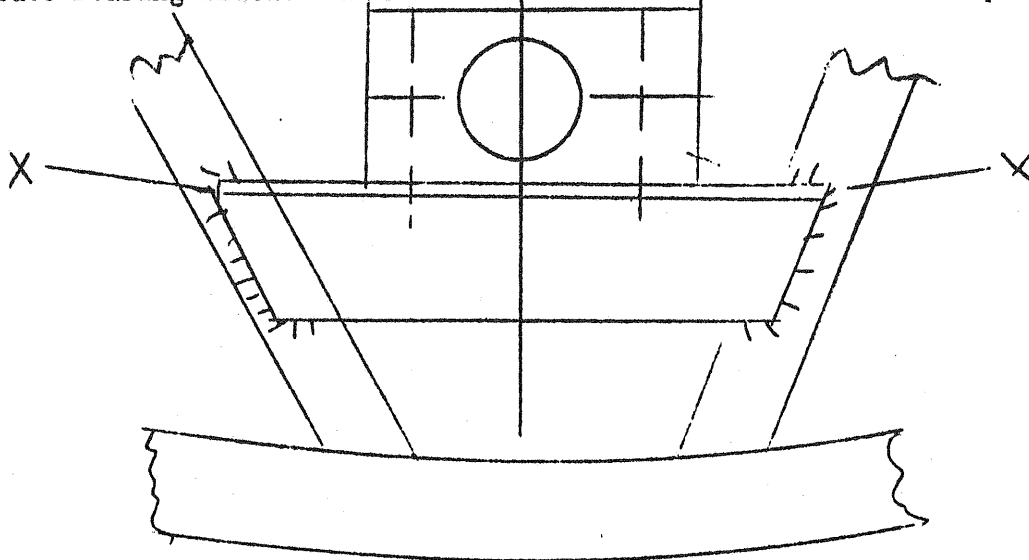
REF 26H136

We have a field report of a weld failure at the forward Control Torque Tube Bearing Bracket marked "X". Effective Serial No. 2 and up.

While we believe this to be an isolated case, we feel that this point should be checked before flight by all owners. It is readily accessible for inspection. If any cracks are found, please advise us.

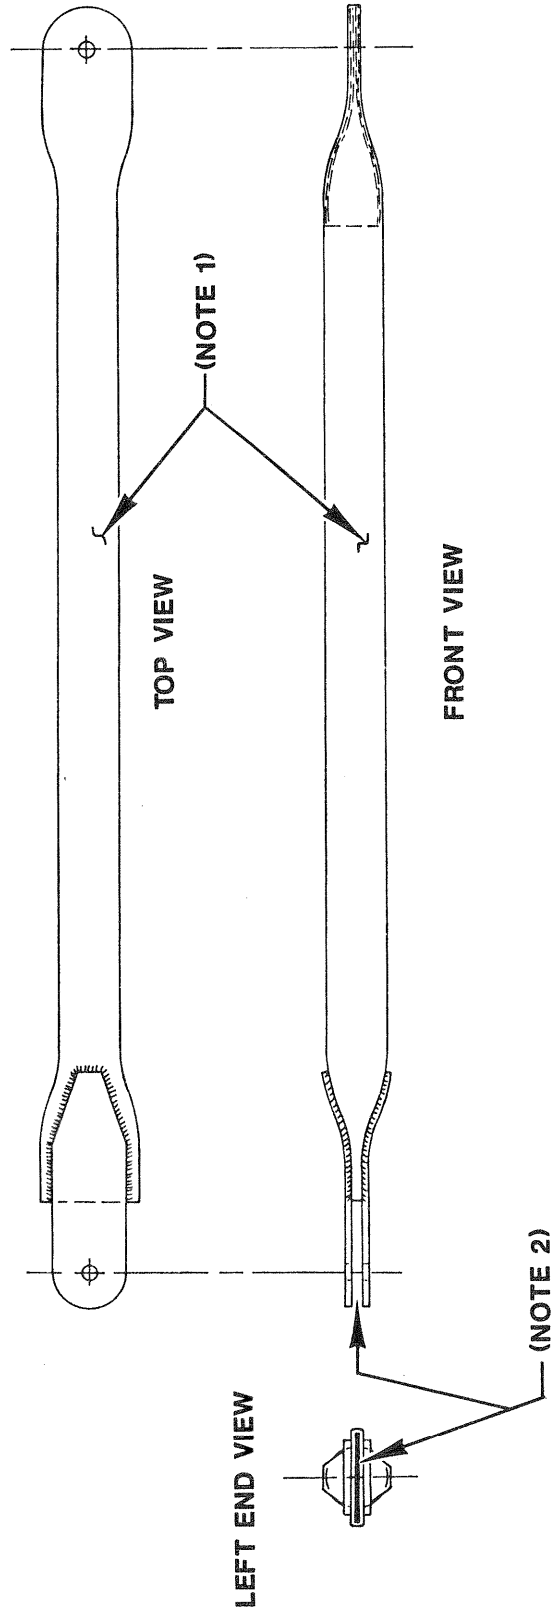
FIGURE 1. ELEVATOR PUSHROD (P/N 26B-12 -1A)

PREFACE: Field reports have indicated a possibility of corrosion of the subject 26B-123-1A push rod assembly. This corrosion, if left uncorrected, could lead to failure of the push rod, resulting in a loss of control of the elevator. This Service Bulletin provides instructions for a repetitive visual inspection of the subject push rod assembly. Any corrosion (no matter how slight) found during the inspection is cause for removal of the push rod assembly (PN 26B-123-1A) from service. 26B-123-1A push rods which are found to be completely free of corrosion may be returned to service after a coat of hot linseed oil is applied to the push rod interior surface, as set forth here in. It should be noted that the 26147B push rod is made from an improved design and is not subject to the inspection specified in the below procedure.

- NOTES: 1. INSPECT EXTERIOR OF PUSHROD FOR CORROSION.
NO CORROSION IS ALLOWED.
2. INSPECT INTERIOR SURFACE OF PUSHROD FOR CORROSION BY SHINING
HIGH INTENSITY LIGHT THROUGH OPEN END OF TUBE.
NO INTERIOR CORROSION IS ALLOWED.

- e. If any interior or exterior corrosion is found, replace push rod with a serviceable 26147B-1 push rod. If there is any question whether interior or exterior corrosion exists, replace push rod or consult the factory.

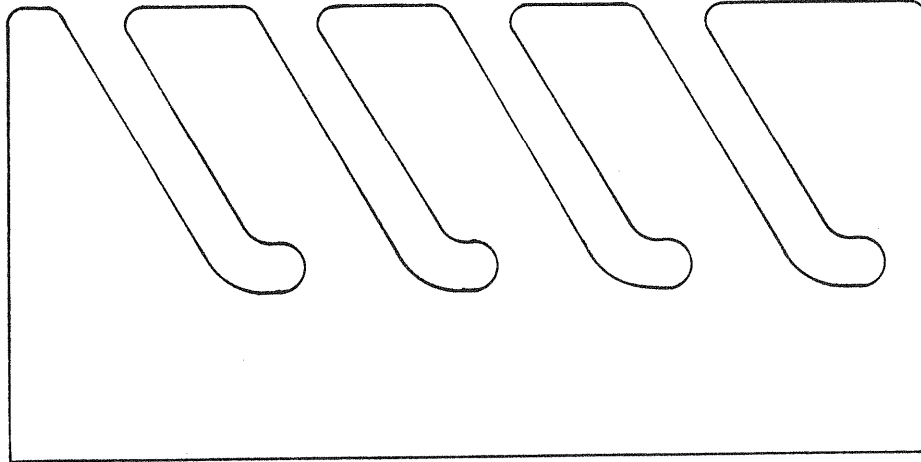
NEW DESIGN 26245D-3 BRACKET

PREFACE: Reports indicate that on the affected aircraft, the pilot's seat back could inadvertently slide back during tow, when experiencing turbulence or during certain flight attitudes where a negative g condition may exist. A new bracket, (PN26245D-3), and spacer, (PN26245D-5), has been designed to resolve this problem. This service bulletin lists instructions to install this improved seat back adjustment bracket. This improved bracket should reduce the possibility of sudden seat back movement.

- a. Drill out rivets securing existing seat adjustment brackets. Remove brackets.
- b. Clean up bracket mount area removing any burrs and sharp edges.
- c. Paint bracket mount areas with a thin coat of Zinc Chromate or equivalent primer to prevent corrosion.
- d. Place the spacer between the inside fuselage wall and the lower edge of bracket.
- e. Mark the mount area and drill holes as per old bracket using a #30 drill bit and secure with Cleco.
- f. Install rivets (MS20426AD4) (5) places on each bracket and spacer kit.
- g. Paint exterior of rivet heads.
- h. Record compliance with this service bulletin in the aircraft log book.
