# PUBLICATION INDEX

### SGS 2-33

BULLETIN NO. SA-001.6\*

SUBJECT: ONE-TIME INSPECTION OF TOW RELEASE ASSEMBLY; DAILY INSPECTION OF TOW RELEASE ASSEMBLY; PILOT'S PREFLIGHT INSPECTION OF TOW RELEASE ASSEMBLY; 100 HOUR/ANNUAL INSPECTION OF TOW RELEASE ASSEMBLY.

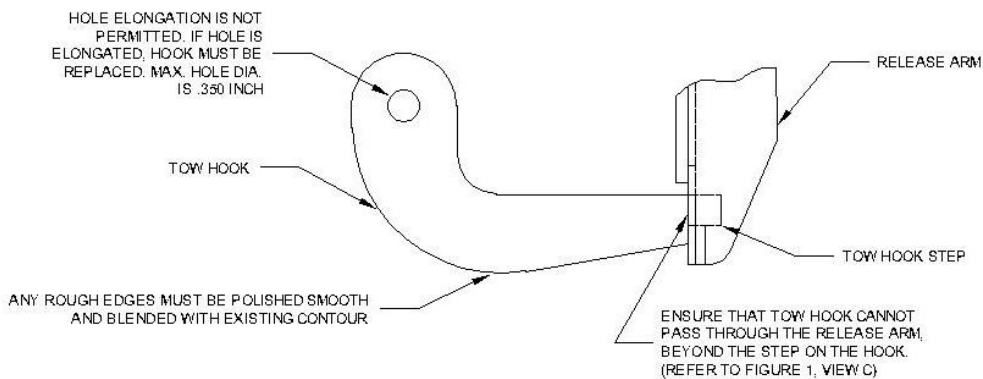
FIGURE 4 - PULL TEST OF TOW RELEASE ASSEMBLY

NOTE: IF RELEASE LOADS ARE TOO HIGH WITH C.G. SYSTEM IT IS PERMISSIBLE TO ADD A LINK TO SHORTEN STD 1A141-2 SPRING. LINK SHOULD BE MADE AS SHOWN BELOW. IF REQUIRED THEY SHOULD BE ADDED TO BOTH RELEASE ARMS TO BALANCE BOTH RELEASE SPRINGS

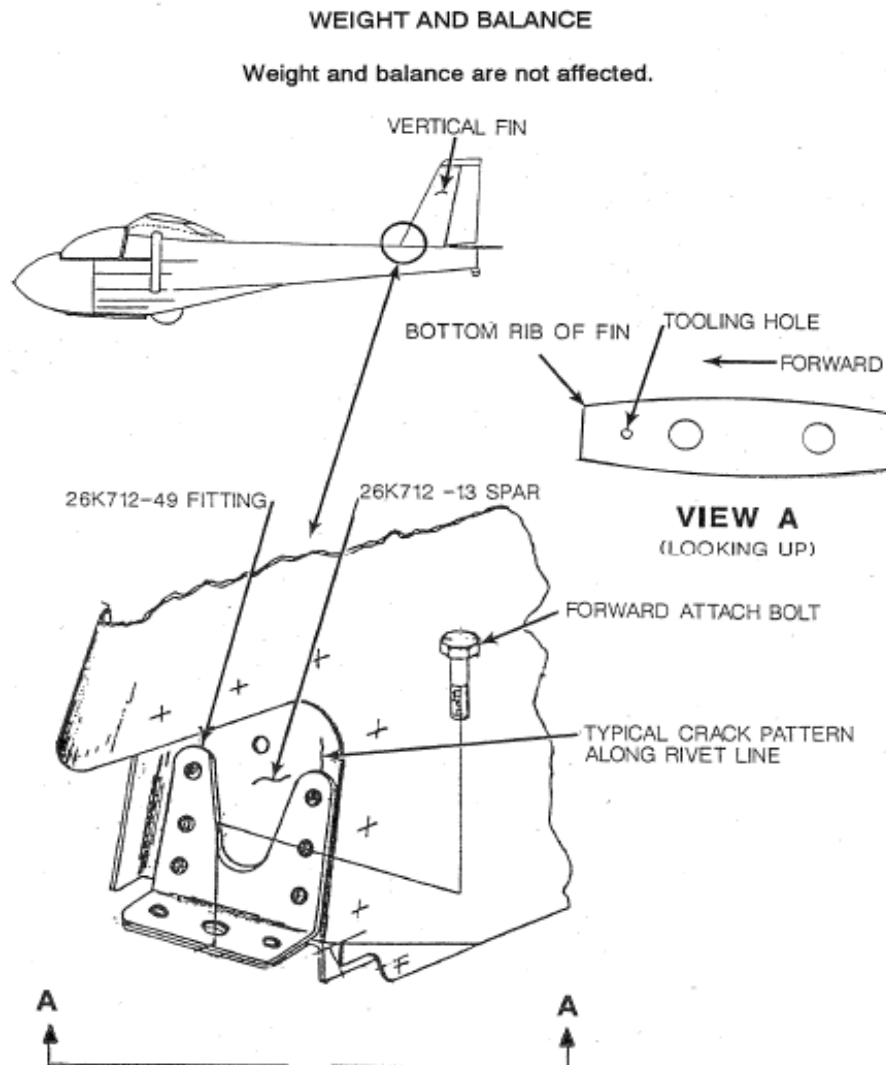
Figure SA-008-1 Vertical Fin Forward Attach Point

PREFACE: Field reports indicate that cracking was discovered in the forward spar of the vertical fin, and the forward fin attach bolt was loose. This Service Bulletin provides the inspection procedure to check for cracking and hardware security.

- A. Remove access cover from the lower edge of the vertical fin, to expose 26712-49 fitting (Figure SA-008-1).
- B. Visually inspect for cracks in the 26712-13 spar propagating from behind the -49 fitting and check for security of the forward attach bolt. Perform the following steps, as applicable:
- C. If cracking is found, contact K&L Soaring for repair instructions (607) 594-3329.

- D. If cracking is suspected, but not confirmed, or if the forward fin attach bolt is loose, perform the following:
1. Remove the vertical fin from the aircraft (2-33 & 2-33A Manual)
  2. Enlarge the forward tooling hole in bottom rib of vertical fin to one inch maximum (Figure SA-008-1, Detail A). Use the enlarged hole for visual access to inspect for cracking on the back side of the -13 spar. If cracking is found, perform step C above.
  3. Install vertical fin on aircraft (2-33 & 2-33A Manual)  
FAA AD Note 76-13-11 was previously performed, remove plugs from above
- E. Ensure that forward fin attach bolt is tight; then install access cover on vertical fin.
- F. Record compliance with this Service Bulletin in the aircraft records.

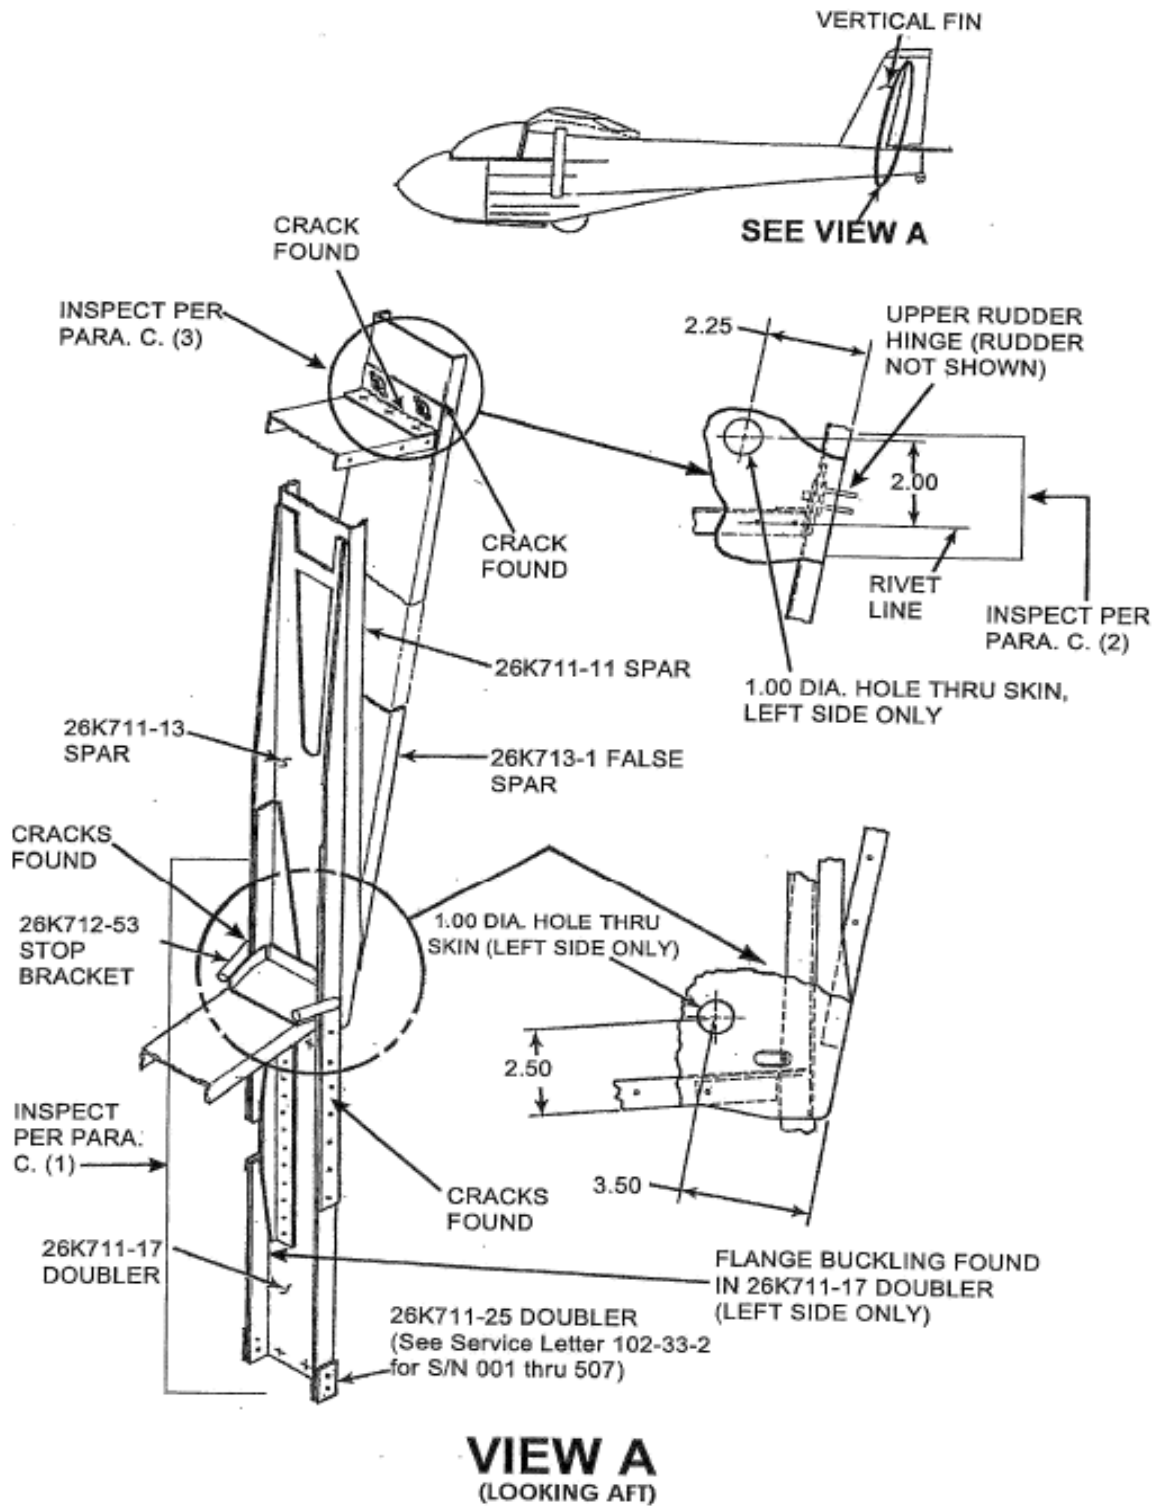
Figure SA-010-1. Vertical Fin Rear Spar Inspection

PREFACE: Since the original issuance of this service bulletin there have been four additional field reports of fin spar cracking at the upper rudder hinge point. Three of these aircraft had less than 6,500 hours total time, the lowest being 3,450 hours.

There have been field reports of damage found on the rear spar of the vertical fin. Some of these reports involved high time sailplanes (over 11,000 hours) with cracks in the spar (and spar doubler). Cracks were found on the left-hand spar flange (and doubler) just below and under the fin skin running around the mold line towards the upper left hand fin/fuselage attach point. Additional cracks were found in the 26K713 false spar and rib clip angle under the uppermost rudder hinge. On another sailplane, cracks were found above the rudder stop fitting. (See Figure SA-010-1)

The remainder of the reported damage consists of buckling (with and without cracking) found on the left side spar doubler flange midway between the upper and lower fin/fuselage attach points.

- C. Using a mirror and flashlight, inspect the following: (Figure SA-010-1)
  1. Inspect the rear spar assembly, from the bottom to above the rudder stop fitting, for evidence of buckling, cracking, or other deterioration. Check the four attach bolts for tightness.

2. Inspect the false spar (aft face) around the upper rudder hinge. Look specifically for any cracking that emanates from under the hinge doubler and may only have traveled 1/8 inch or less beyond the doubler.

3. Through the upper hinge inspection hole, inspect the clip angle and false spar for cracking forward of the upper rudder hinge (Figure SA-010-1)
- D. If damage is found, remove the aircraft from service and contact K&L Soaring for repair instructions. (607) 594-3329

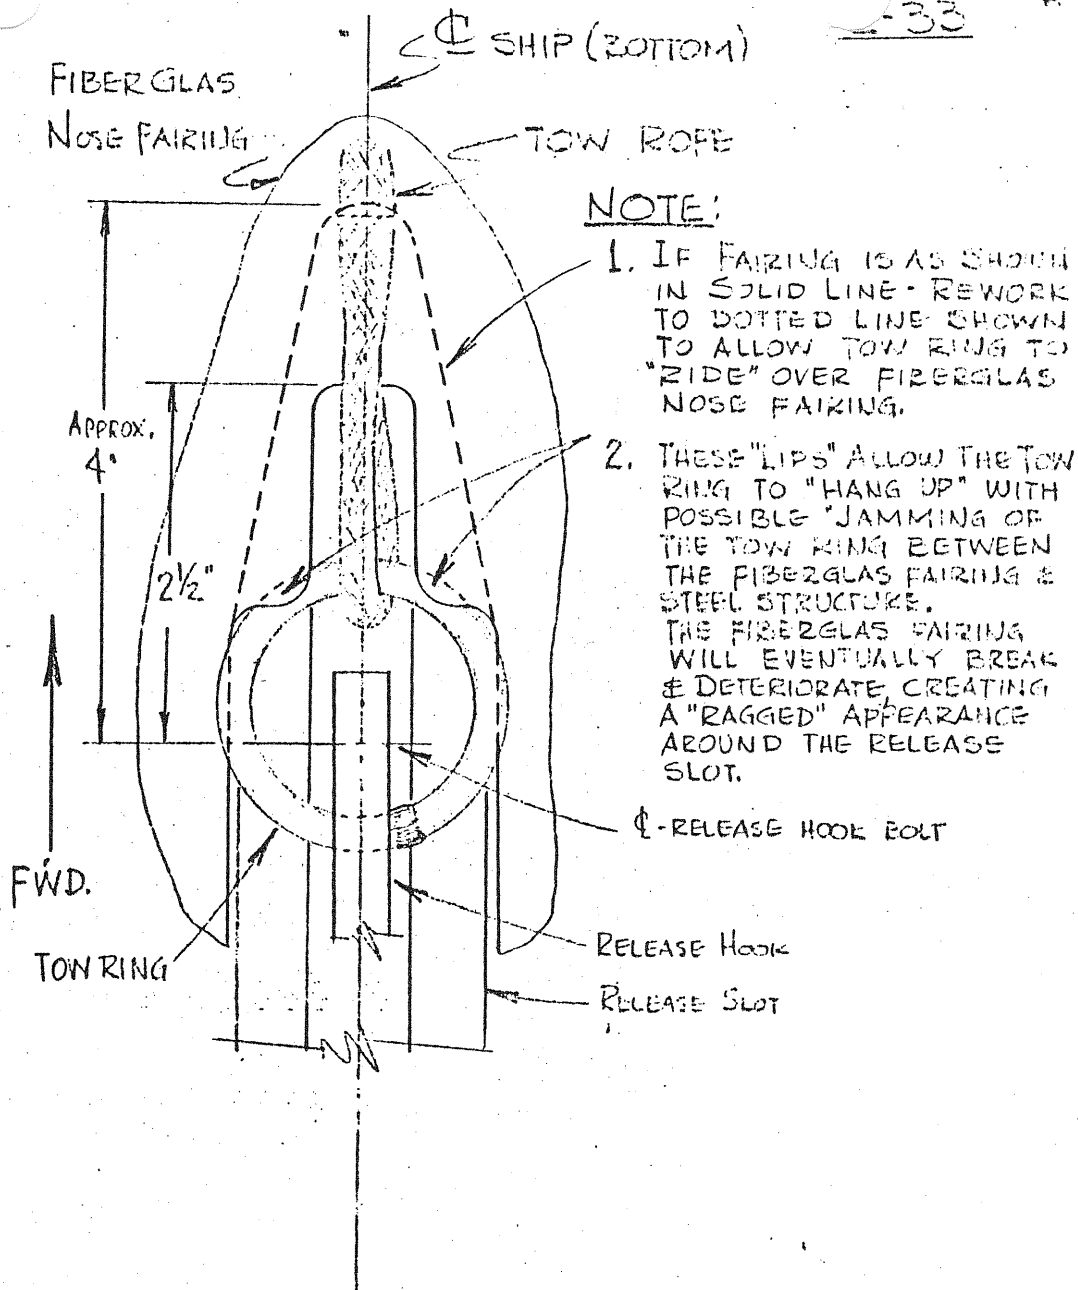
4550A

Should this happen, the forces involved would simply tear the tow ring from under the fiberglass fairing and not endanger further flight, however damage such as this is obviously undesirable.

To prevent the above possibility it is recommended that the fairing opening be reworked in accordance with Schweizer sketch No. 4550A, copy of which is attached to this letter.

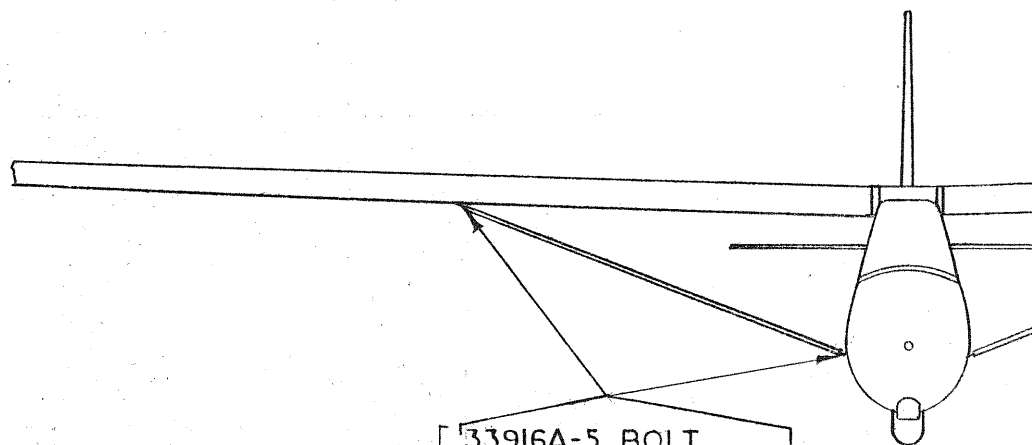
## SGS 2-33 WING STRUT ATTACH OPTIONS

Occasionally, reports have been received from the field of a problem, primarily with the option no. 4 in sketch below. The usual report was that the attach bolt had backed out to the point where one or more threads were in bearing. Part of the reported problem may be attributed to inadequate Preflight Inspection.

OPTIONS ARE NUMBERED IN ORDER OF PREFERENCE
