PUBLICATION INDEX

SCHWEIZER SAILPLANES

K & L SOARING, LLC
5996 STATE ROUTE 224
CAYUTA, NY 14824

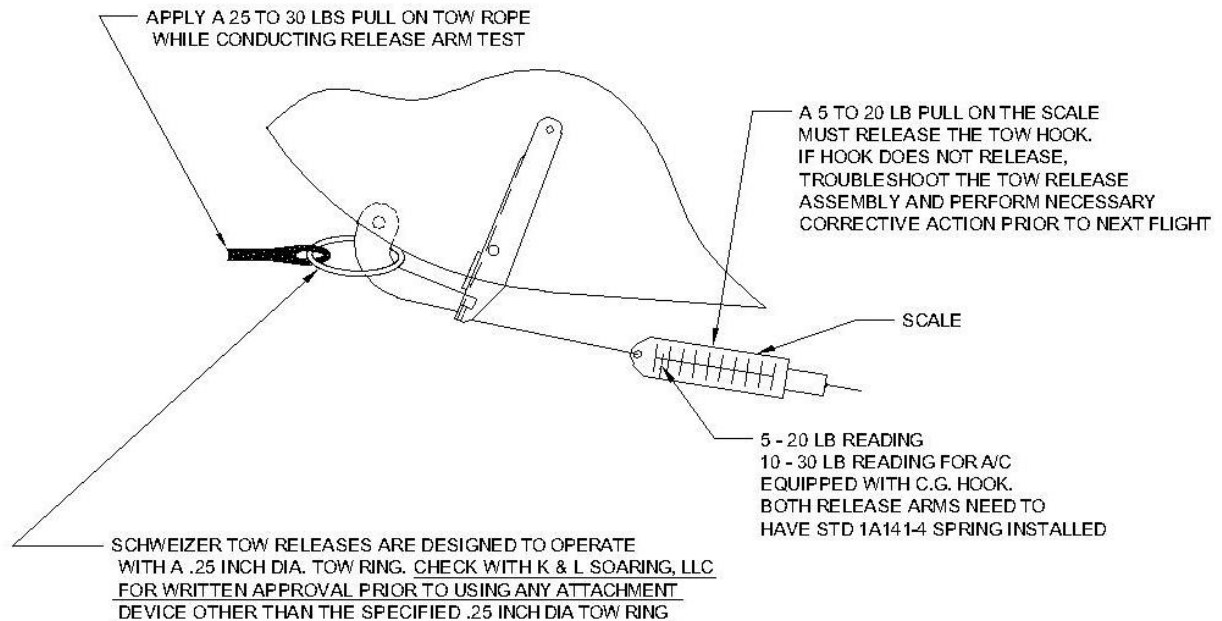
FIGURE 3 - REWORK OF RELEASE ARM

- g. If tow hook is able to travel too far inboard as shown in Figure 1, View C, disengage tow hook from release arm and measure the length of the release arm slot
- h. If dimension is less than 0.66 inch, rework release arm by welding on 1B-217-19 slug at location shown in Figure 3. (Release arm may be replaced as an alternate to welding on slug)
- i. If length of release arm slot is greater than 0.66 inch, replace release arm.
- j. Perform a thorough inspection of the tow hook installation in accordance with the 100 hour inspection requirements listed in Table 2 of this bulletin.
- k. Repair or replace unserviceable component(s), as required
- l. Record compliance with Part I of this Service Bulletin in Aircraft Log Book.

IF TOW HOOK IS ABLE TO SLIDE THROUGH RELEASE ARM, BEYOND THE TOW HOOK STEP, THE RELEASE ARM MUST EITHER BE REWORKED IN ACCORDANCE WITH FIGURE 3, OR REPLACED

NOTE: ALL TOW RELEASE ARMS MUST BE REWORKED AS SHOWN ABOVE OR REPLACED WITH THE PROPER SUPERSEDING ARM AS SPECIFIED IN TABLE 1

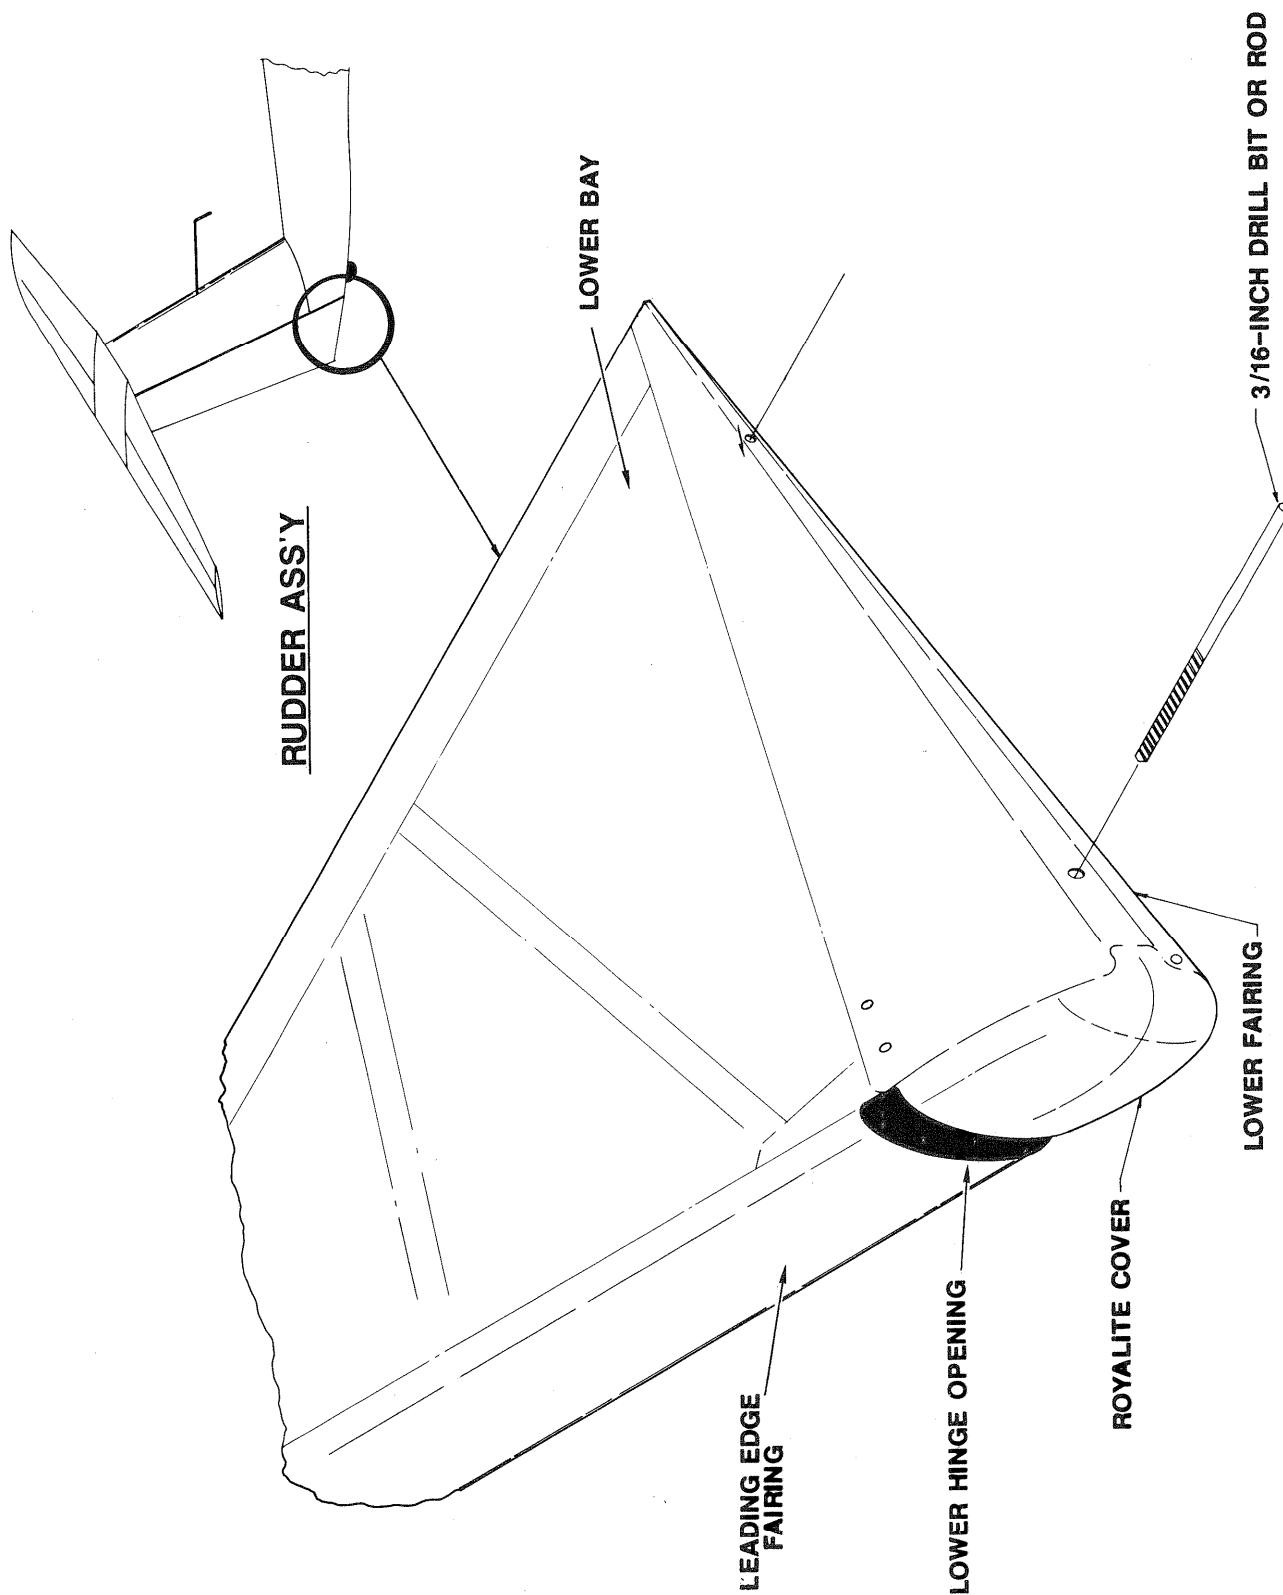
FIGURE 1

- (1) Carefully adjust rudder position to extreme left or right.
 - (2) Using a flashlight, inspect for debris inside lower fairing (Figure 1) by looking through lower hinge opening.
 - (3) If debris is found, use a vacuum cleaner with flexible extension hose to remove debris.
 - (4) Check two drain holes (Figure 1) at bottom of fairing for obstruction. Clear obstructions with 3/16-inch drill bit.
- d. Open access door on horizontal stabilizer stub (Figure 2) and use a flashlight to inspect upper fin and stabilizer stub area for debris. Use vacuum cleaner to remove debris.
- e. Inspect brake/wheel area for obstructions. Remove obstructions as required.

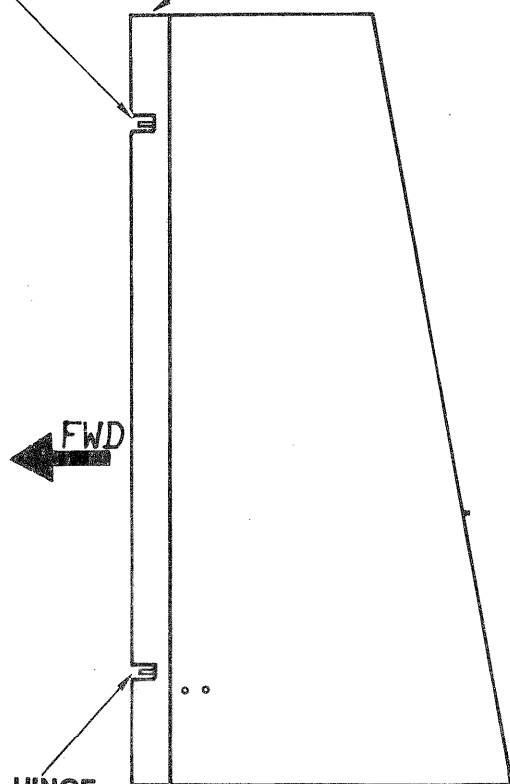
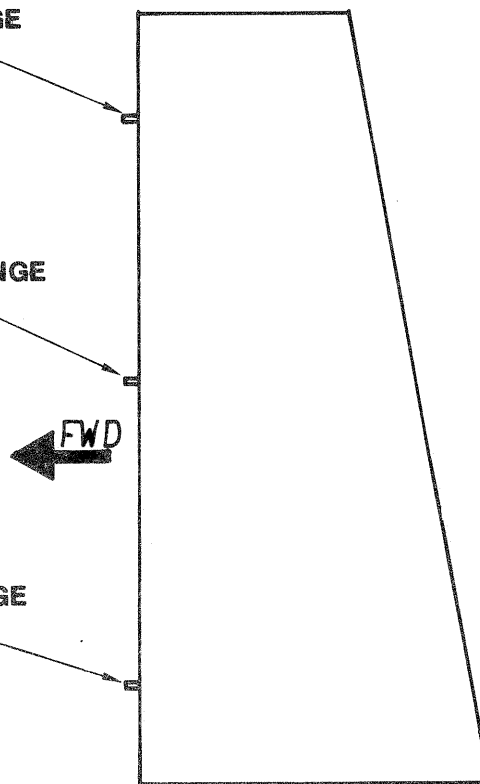
FIGURE 3

One of two types of tail rudders may be installed on the affected aircraft. The earlier type is an unsealed unit without a leading edge fairing (Figure 3, Detail B). The later type is sealed at the leading edge by a fairing (Detail A). Removal of an unsealed rudder is accomplished by performing step a(1) through a(3). A sealed rudder is removed by performing steps b(1) through b(3).

- c. Using a flashlight and inspection mirror, inspect for debris inside of rudder by looking through hinge openings (Figure 3, Detail A or Detail B, as applicable).
- d. If debris is noted between leading edge fairing and spar, remove debris through upper hinge opening, using vacuum cleaner and flexible extension hose.

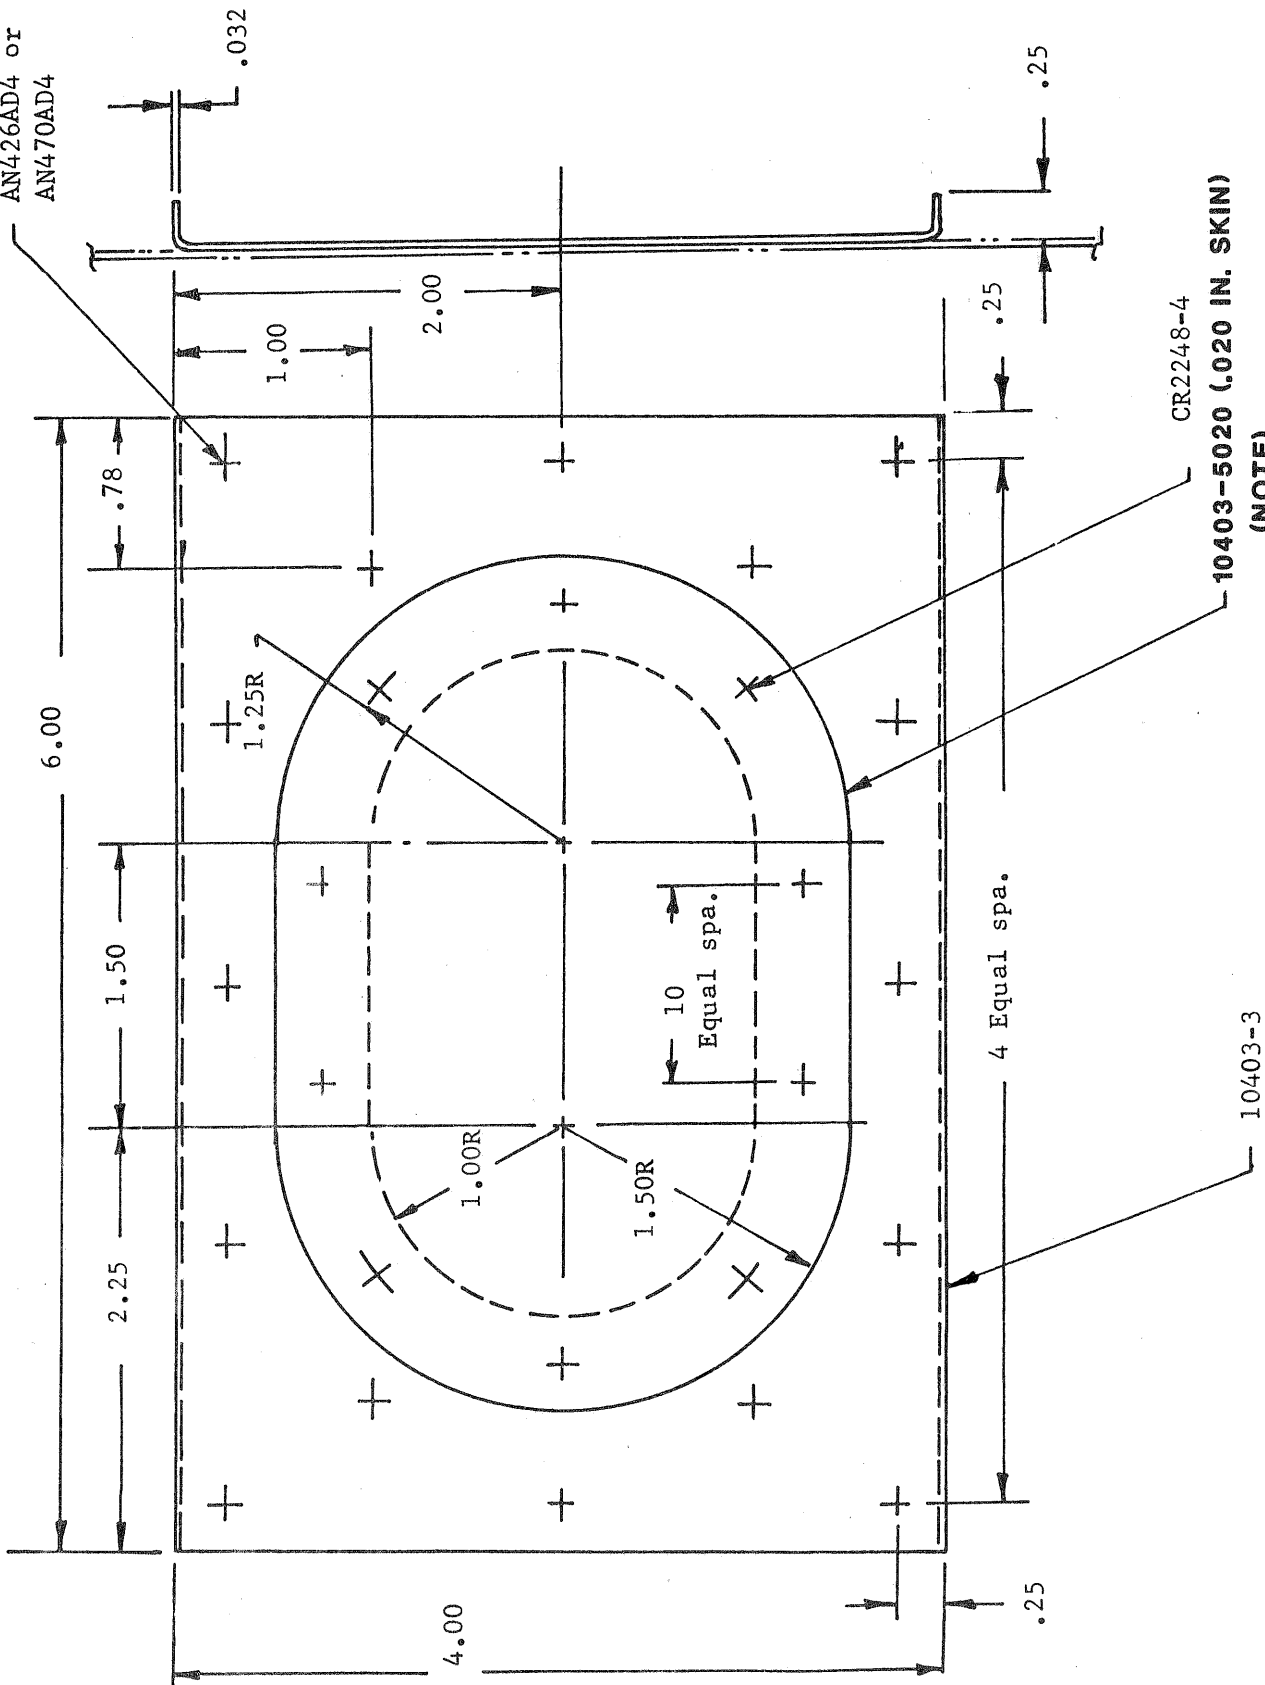
FIGURE 5. STRUCTURAL DOUBLER ID PATCH

Doubler
.032 2024-T3 Alc.
NOTE: EARLY SGS 1-35 SAIL PLANES WHICH INCORPORATE
A .016 IN. SKIN REQUIRE A 10403-5016 PATCH.

- (2) Use vacuum cleaner with flexible extension hose to remove debris from lower portion of tail fin.
 - (3) Using doubler as a template, install appropriate number of rivet holes (of proper size) in tail fin skin at locations shown in Figure 5.

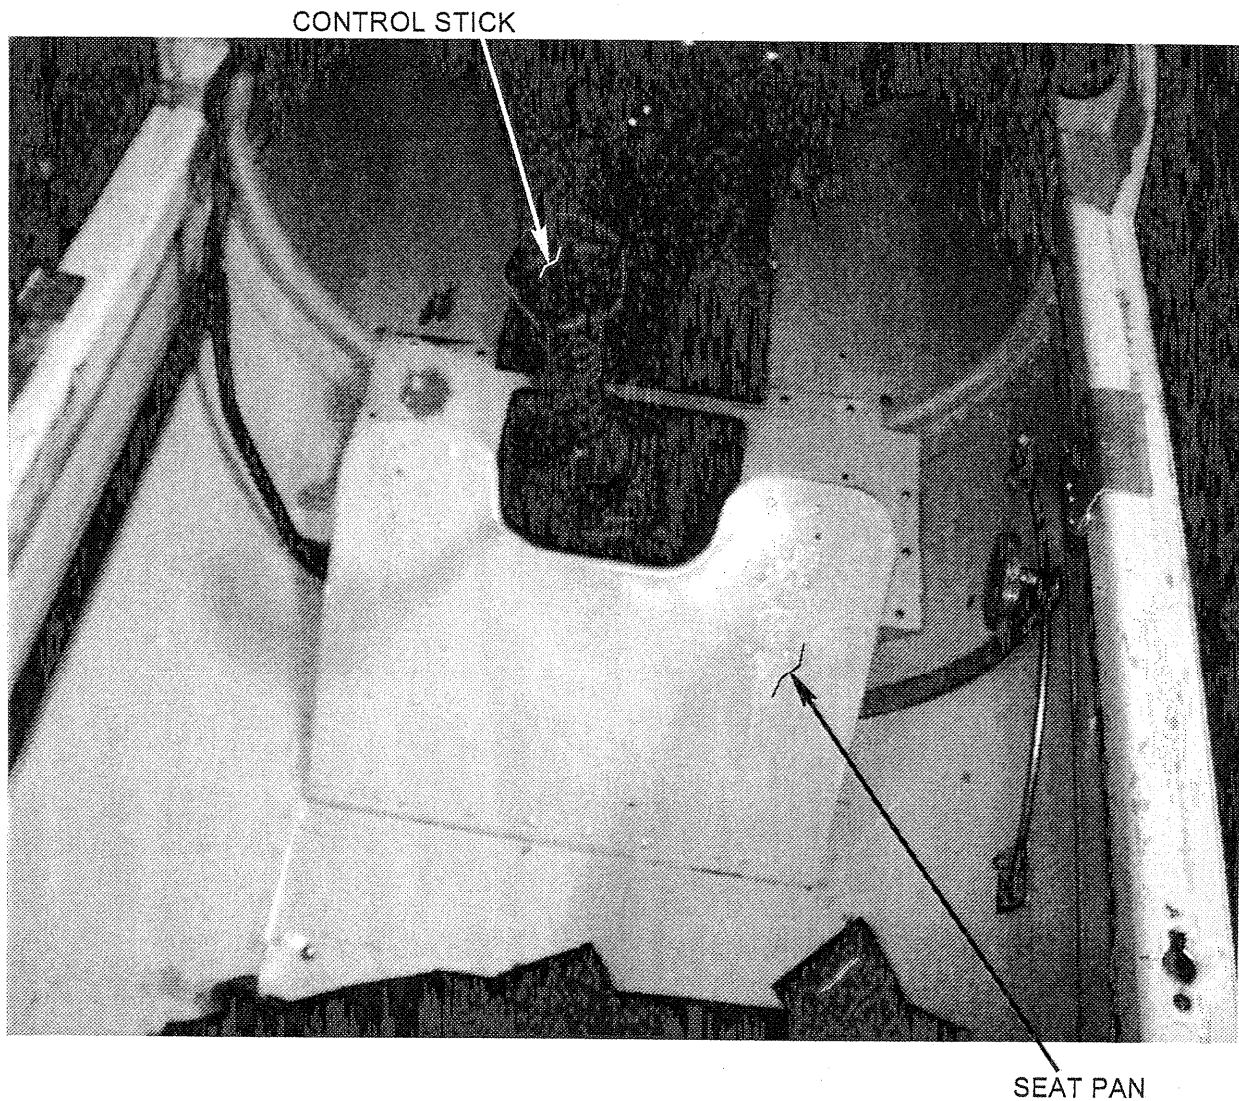
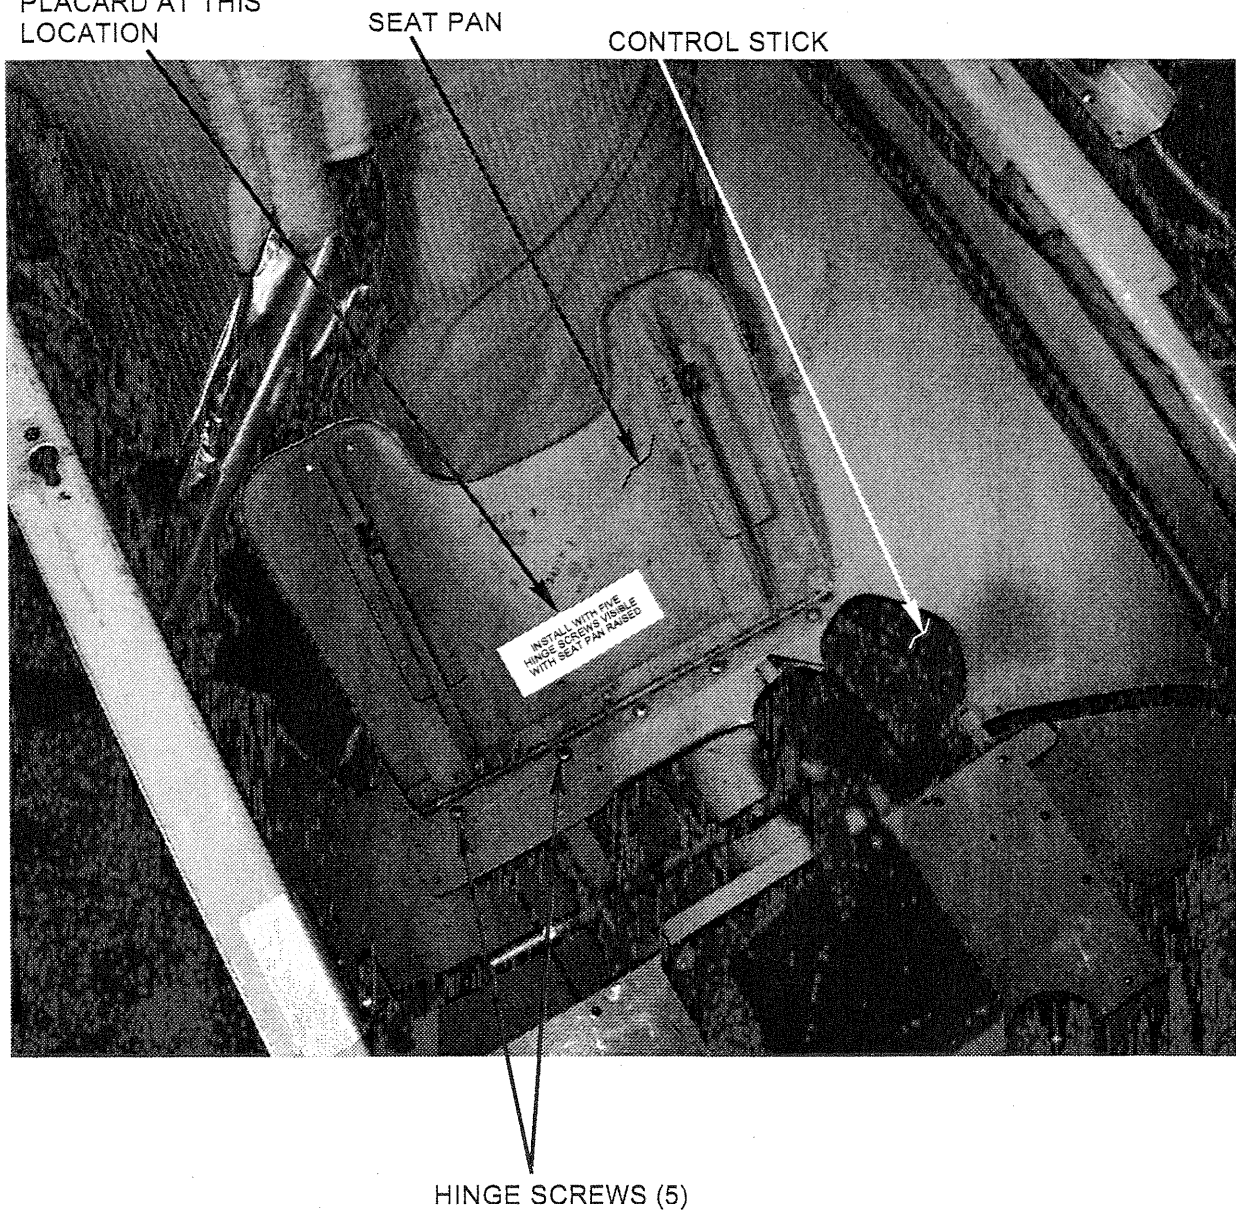
Figure SA-012-1. Seat Pan in Normal Position (Bottom Seat Cushion Removed)

INCORRECT INSTALLATION RESULTS IN LIMITED
STICK TRAVEL AND POSSIBLE LOSS OF NOSE-UP
CONTROL, AND CONTROL OF THE AIRCRAFT!

**INSTALL WITH FIVE
HINGE SCREWS VISIBLE
WITH SEAT PAN RAISED**

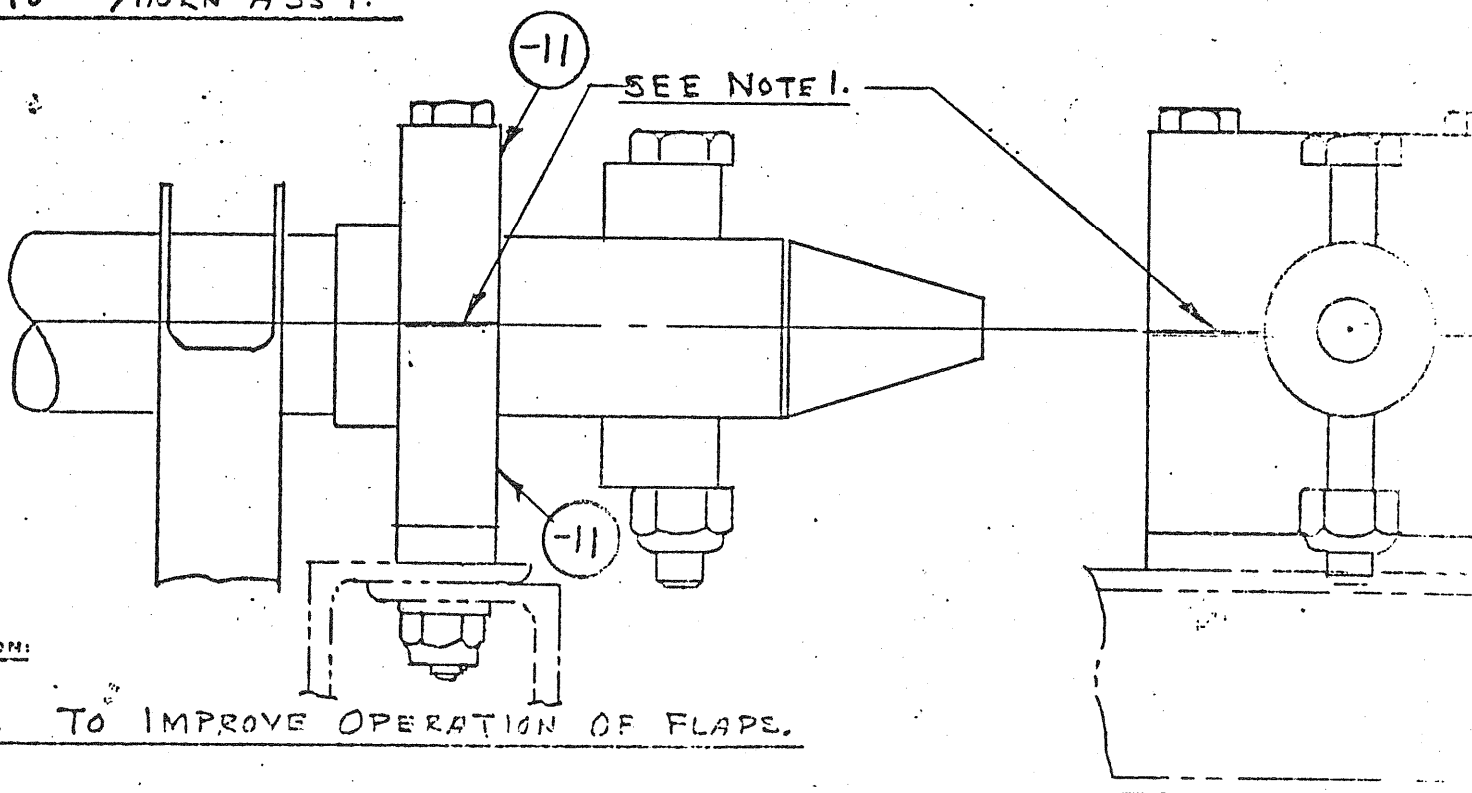
1. - 2. TO IMPROVE OPERATION OF FLAPS.

1. WITHOUT PUSH ROD ATTACHED ADJUST (1) PAIR OF -11 BEARING BLOCKS (L.H.) TO GIVE A FRICTION TORQUE ON TORQUE TUBE OF 5-8 IN. LBS. -11 BLOCK MAY BE FILED LIGHTLY TO ACHIEVE THE FINAL RESULT. WING PANELS SHALL BE REMOVED WHEN DOING THIS MOD.

2. F/D. ADD: SEE NOTE 1. TO CENTERLINE OF (2) -11 BLOCKS ADJACENT TO -7 HORN ASS'Y.

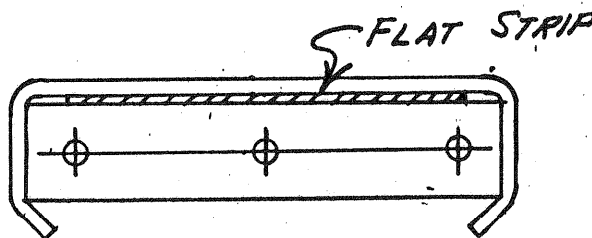
FIG. V

Minimum thickness of spacer should be .040 and maximum thickness is .093. Width of spacer should full 5/16" so that there is no excessive gap at the edges.

If more than .093 is required, use a flat strip 5/16" wide between the space and the block as shown in Fig. V.

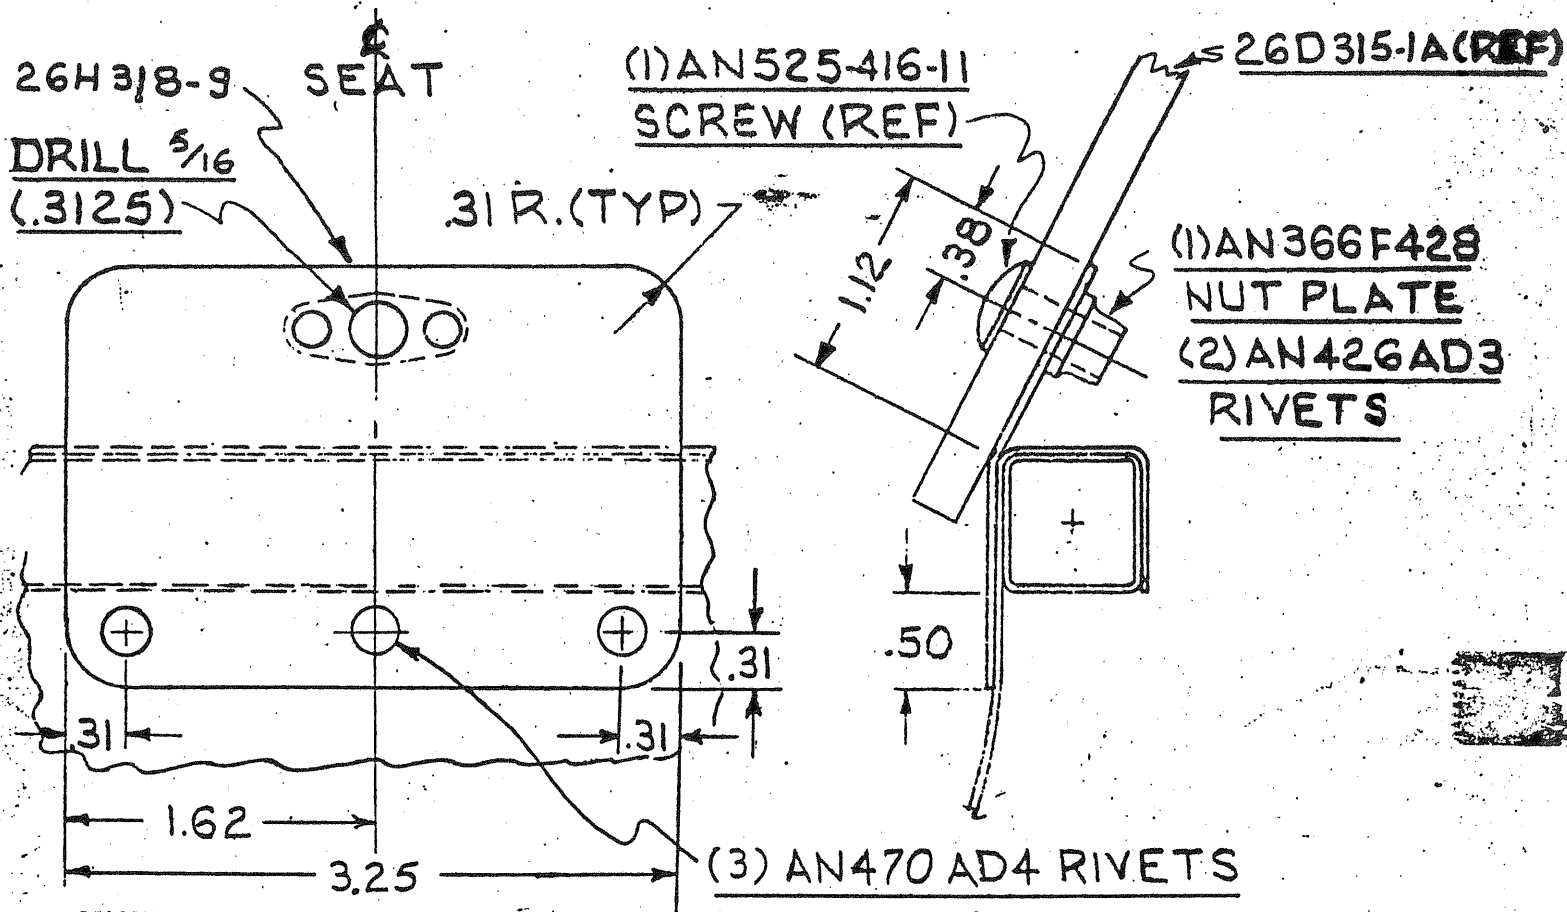
1. TO PROVIDE ADDITIONAL ATTACHMENT
FOR SEAT BACK.

1. ADD ATTACH PLATE TO SEAT AS SHN.
MAKE FROM .040 2024-T3 ALC
