PUBLICATION INDEX

SGS 1-26

K & L SOARING, LLC
5996 STATE ROUTE 224
CAYUTA, NY 14824

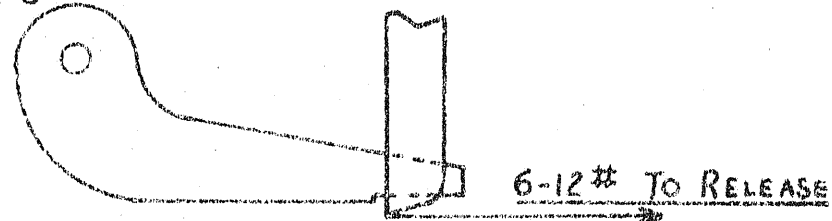
All 1-26's should be equipped with this spring. The installation should be checked by pulling on the release arm just below the hook with a small spring scale. This should require from 6-12 lbs. pressure to release. (See note on page 2).

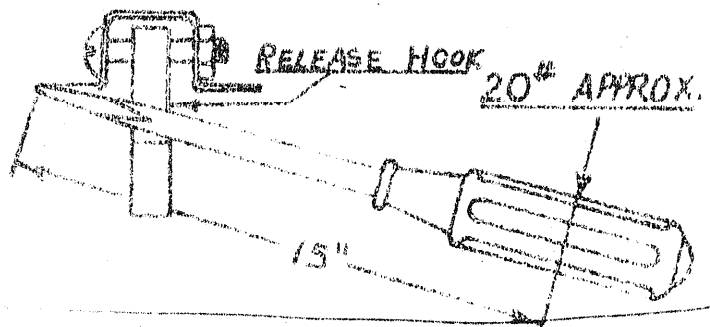
The force required at the release control should be moderate. Check your control system if you feel the operating force is excessive. An additional check which is used at the factory is to operate the release while load is applied at the hook. This is done by applying pressure with a large screw driver or small bar (see sketch). Pilot should be able to release under this condition--it will, however, take more force.

ADD THIS ITEM TO
1-26 MANUAL.
Pg IV-10.3
