# PUBLICATION INDEX

### SGS 2-33

BULLETIN NO. SA-001.6\*

SUBJECT: ONE-TIME INSPECTION OF TOW RELEASE ASSEMBLY; DAILY INSPECTION OF TOW RELEASE ASSEMBLY; PILOT'S PREFLIGHT INSPECTION OF TOW RELEASE ASSEMBLY; 100 HOUR/ANNUAL INSPECTION OF TOW RELEASE ASSEMBLY.

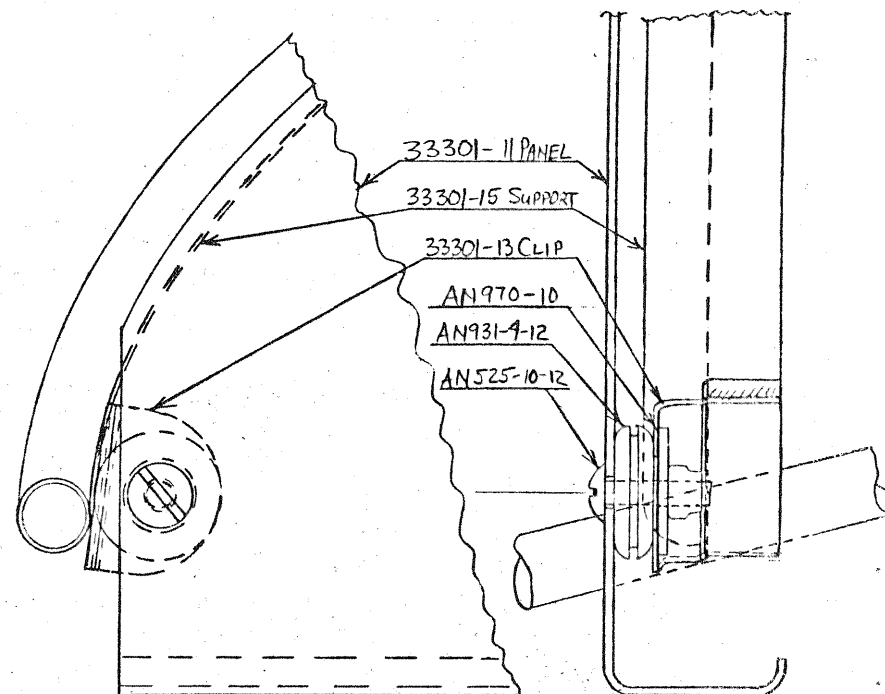
VIEW FORWARD - L.H. LOWER  
CORNER OF INST PANEL SH'N.

Reinstall the knob and rod using the  $\frac{1}{4}$  inch long bumper, reconnect the release cable to the rod and safety.
